CONDITION ASSESSMENT AND STRUCTURAL REHABILITATION OF THE ST. NICHOLAS CHURCH IN CRNA TRAVA

Abstract. *The paper analyzes the structural condition of the church dedicated to Saint Nicholas, which is located in the town of Crna Trava, in the south of Serbia. An architectural analysis of the observed structure is provided, as well as an overview of previous works on it, both research and rehabilitation and conservation. A detailed analysis of the structural system of the church is presented. The analysis and classification of the observed damages was performed, the works on the rehabilitation of the building were presented, and a proposal of further remedial measures was given with the aim of preventing further deterioration of the building.*

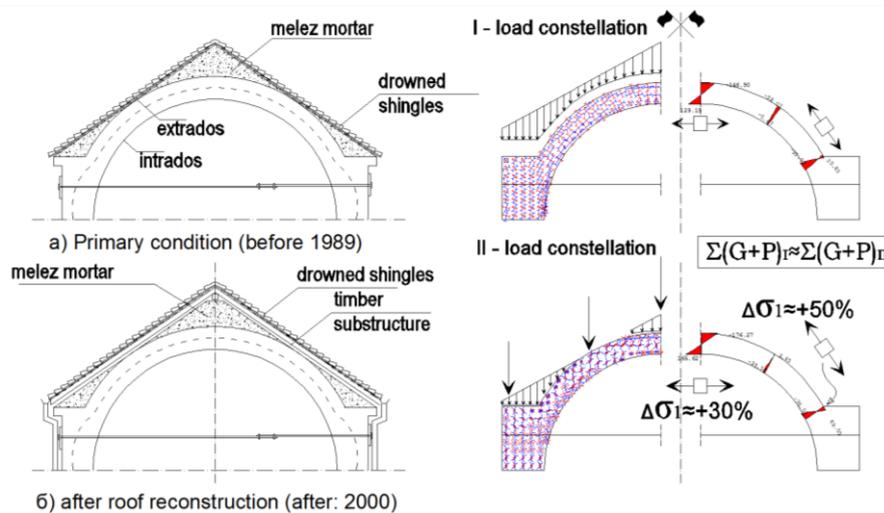
Fig. 3 Change of stress state in the vaults after the self-initiated reconstruction of the roof by the church board, (drawing: P. Petronijević).

During the last reconstruction, the method of load transfer to the vaults was changed from continuous to concentrated. The load from the wooden roof structure was transferred along the top of the vault in the form of linear reactions. Arched structures are sensitive to concentrated load, so that for the same total load, up to 50% higher tensile stresses created by bending are generated on the intrados of the vault (Fig: 3) [7,8].

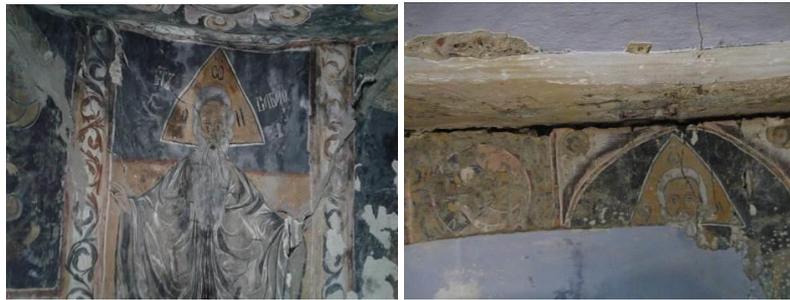
The characteristic of stone masonry vaults is low tensile strength due to low tensile strength of the mortar and insufficient bond between the stone and the mortar [9]. The tensile strength of the vault depends on the type and quality of the mortar with which it is built, as well as the porosity, surface roughness of the stone and the geometric relationships of the stone used for masonry. The compressive strength of masonry vaults is considerable. Although local stone crushing can theoretically occur, global failure due to pressure is unlikely, because the compressive stresses are negligible in relation to the compressive strength of the vault. The cracks in the vault were created by the action of edge tensile stresses caused by bending (Fig: 4). The cracks extend mainly through the mortar and through the joints of mortar and stone.

Fig. 4 Cracking in the barrel vault of the st. Nicholas church, (photo: P. Petronijević)

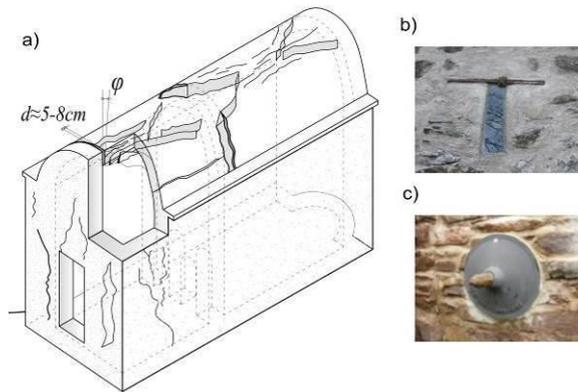
The present damage to the vault is only partly a consequence of the concentration of load that occurred during the inadequate works in the last stage of the rehabilitation works, on the roof of the church. The bracings failure had the greatest effect on the onset and propagation of cracks in the vault. Bracings have the role of receiving the horizontal component of the oblique reactions of the arches. Thus, the longitudinal walls are entrusted exclusively with the vertical component of the reaction of the vaults, i.e. gravitational load.

Fig. 7 a) mapping of cracks, b) influence of wall spacing and different settlement of supports on change of stress state and mechanism of barrel vault fracture [3]

the longitudinal walls. Anchoring was realized with two steel members (see Fig. 7-b) in inadequate places, one brace even passing through the window. Anchoring did not include base plates so there is no possibility of subsequent force correction by increasing the tension. Arched structures are extremely sensitive to the spacing out of the supports. Braces failure and the walls spacing out at the height of the cornice by only 0.1% of the vault the span, increases the tangential tensile stress in the apex and the arch support several tens of times. This exceeds the tensile strength of the mortar multiple times, cracks and fissures occur and the supporting line of the vault is deformed depending on the number of newly formed plastic joints (see Fig. 8-a).

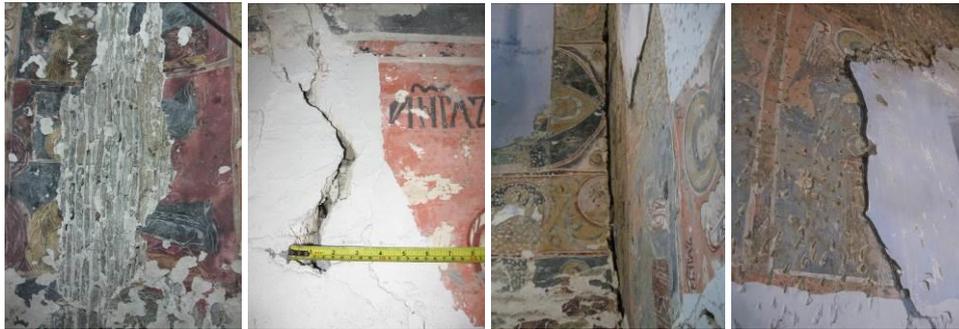
Fig. 9 characteristic cracks between the vault and the transverse walls (photo. P.P.)

Since the walls are the supports of the vaults, their condition is vital for the stability of the structure. The depth to span ratio of the vaults is low so that the load from the roof and the own weight of the vaults are dominantly transmitted by normal forces inside the vault. Inefficient transverse bracing using metal members resulted in considerable spacing out of the support points of the vaults. This caused a flexural deformation that the structure of the vault built of stone is not able to receive. The spacing of the vaults caused the greatest consequences at the junction of the vaults with the transverse walls (Fig. 9).

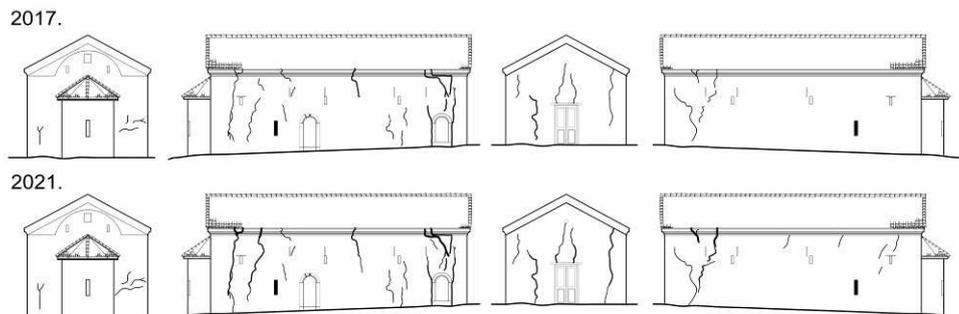
Cracks in the longitudinal walls are present in places (Fig. 10), but they are significantly smaller in width than the cracks in the transverse walls. The width of the cracks registered in the longitudinal walls is up to 2 mm and is probably a consequence of the settlement of the foundations and climatic influences. In general, the causes of uneven settlement can be divided into the original ones, which stem from the inadequate dimensions of the foundations and the subsequent ones, which arose during the service of the building and are the result of water seeping into the foundations. The unevenness of the foundation soil below the building is excluded in this case. The variable depth of the foundations also had a negative effect on uneven settlements, because for the same width of the foundation strip, if the pressure is transferred to the deeper layers of the soil, the settlements are smaller. Extreme climatic conditions caused material fatigue and led to the onset of cracks of smaller or larger width. The highest concentration of cracks is at the junction of the walls in the corners of the narthex and is a consequence of the spacing out of the arches and separation from the transverse walls (see Fig. 9).

Fig. 10 Mapping cracks in the walls, condition from 2017-2021 (drawing: P. Petronijević)

Only the width of cracks larger than 5 mm indicates a significantly disrupted load-bearing structure and function of the walls and endangered stability of the vaults [6]. Although the current width of the cracks in the walls is not large, their arrangement and propagation in the last five years indicates the development of unfavorable processes. The existing map of cracks provides favorable preconditions for the occurrence of characteristic fracture mechanisms of walls during seismic actions. (Fig. 11). The possible unfavorable development of fracture mechanisms is significantly influenced by the absence of ring beams in the cornice and along the height of the wall.

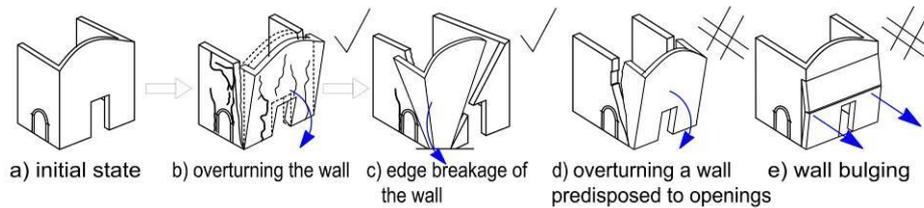
Fig. 11 Potential fracture mechanisms predisposed to the existing crack system

Horizontal movement of the cornice of the walls can be caused by: excessive horizontal component of the vault thrust force, rotational failure of the foundation structure, loss of tensile force in the braces, reduction of the vertical load. With the reduction of the horizontal load-bearing capacity of the wall and the spacing of the vault, a system of characteristic cracks appears within the deformed zone of the vault. Its manifestation is the separation of the vault from the walls, the occurrence of longitudinal cracks, and an increase in the deflection of the middle of the vault.
