## **“KARAĐORĐEV DOM” IN RAČA: TAKING THE FIRST STEPS OF CULTURAL PROPERTY REHABILITATION PROCESS**

**Elena Vasić Petrović**

DEarhitektura Niš, Serbia

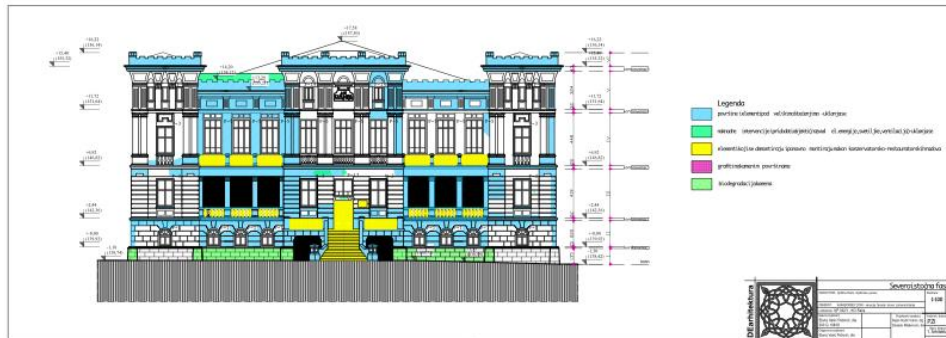
**Fig. 4** "Karadžorđev dom", main façade (northeast) deterioration mapping, author: E.V.Petrović (November 2020)

Insufficient maintenance of protruding parts of the building and façades: due to the long-term absence of proper use, parts of the building that protrude in relation to the basic façade plane, as well as terraces and entrance balcony, suffer constant negative effects of water, frost, and other weather influences. The resulting damage progressively increases in the cycles of freezing and thawing of water, large temperature fluctuations etc. (see Fig.4).

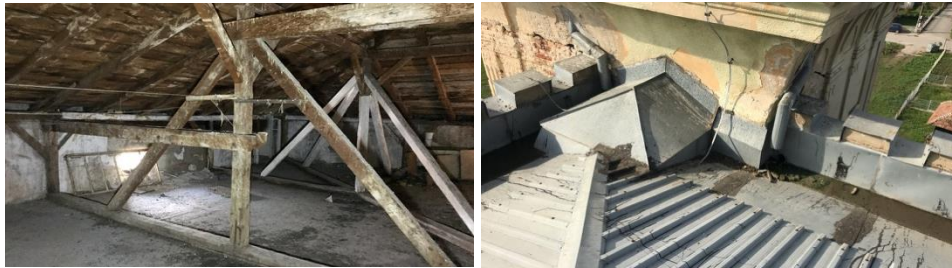
This installation caused great damage to the façades and in some internal parts of the building, and the fact that the last reconstruction of the roof was somewhat clumsily and carelessly carried out contributed to a large part of the roof structure itself suffering damage (see Fig 5).

**Fig. 5** “Karađorđev dom”, interior of the attic (left), damage caused by inappropriate roof reconstruction (right) author: E.V.Petrović (November 2020)

Special attention is paid to the roof structure, where it is estimated that 100% of the roof planking, 80% of the rafters and 40% of the rest of the supporting structure must be replaced (see Fig.5). It is made entirely of wood and consists of a central part and independent roof structures in the towers and above the protruding front part of the building, so there are five in total. All roofs are hipped, covered with metal panels. Roof constructions and roof planes are positioned behind the superstructures, so that in general the construction of such roof created a potential problem for a period in which there is no continuous maintenance or as in this case for a period in which there is a complete absence.

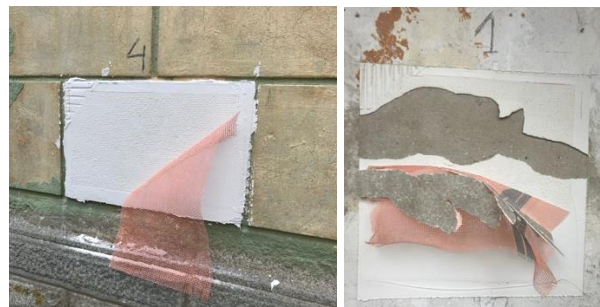
**Fig. 6** “Karađorđev dom”, “pull-off” test results (test No4)-left, test results (test No1)-right, author: E.V.Petrović (November 2020)

The results of the tests showed that the mortar used for plastering of the façades was extremely durable. Only one, out of four test zones, was in bad condition and that the entire mortar layer must be removed there (see Fig.6).
