BELT CONVEYOR DRIVE GEARBOX PROBLEM CAUSED BY UNPAIRED GEARS- A CASE STUDY

Abstract. *Belt conveyors for all kinds of materials are very important piece of equipment in mining and excavation industries. This paper presents a case study analysis of vibration on a belt conveyor driving unit. The analyzed belt conveyor is operating in copper production plant and it is conveying copper ore from mining site to process plant. In order to detect the possible defects in belt conveyor drive units, vibration measurements are conducted in all four drive units. Measurement points are set on bearing housings of electric motor and gearbox as defined by ISO 10816-1.*

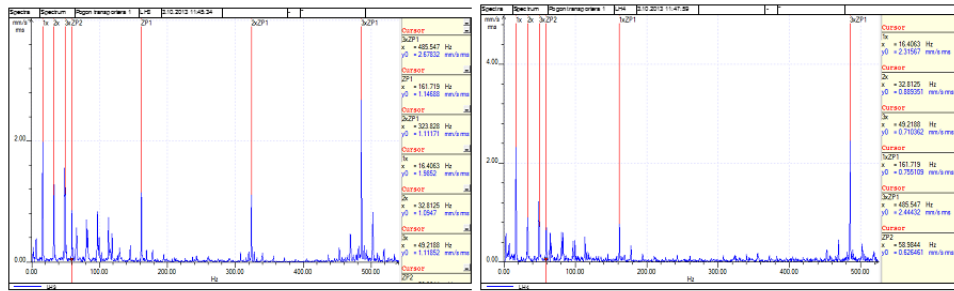
Frequency spectrums measured on gearbox indicate that higher vibration levels are caused by first stage gears misalignment. This is determined by high amplitudes of first stage gear mesh frequencies harmonics – GMF1, GMF2 and GMF3.

LH3 [mm/s]	LV3 [mm/s]	LH4 [mm/s]
1xGMF1 - 161.7Hz	1.15	3.26	0,75
2xGMF1 - 323.8Hz	1.1	2,84	2,44
3xGMF1 - 485.5Hz	2.8	1,15	2,35
1xGMF2– 58.88Hz	0.2	0.4	0.3

Fig. 11 Drive unit 1-LH3, LH4 gearbox input shaft-frequency spectrums first stage gears misalignment

Excessive vibrations on drive units 1 are mainly caused by shaft misalignment between electric motors and corresponding gearboxes. Gear misalignment on drive unit 1 gearbox is noticeable but it could be fixed relatively easily.

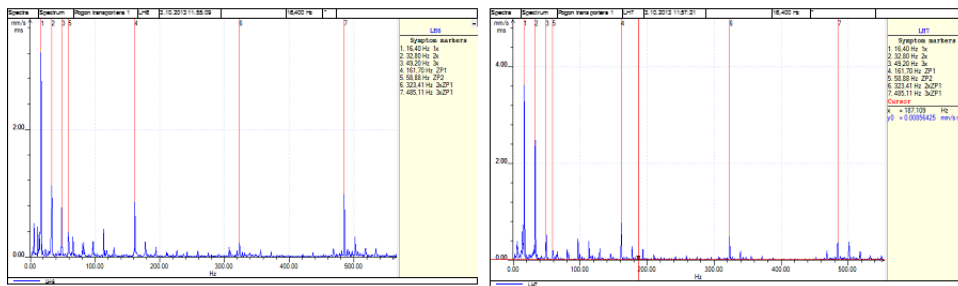
LH5 [mm/s]	LH6 [mm/s]	LH7 [mm/s]
1xGMF1 - 161.7Hz	0.7	0.8	0.8
2xGMF1 - 323.8Hz	1.2	0.4	0.6
3xGMF1 - 485.5Hz	1.0	1.1	0.4
1xGMF2 - 58.88Hz	0.2	0.4	0.3

Fig.12 Drive unit 1–LH6, LH7 gearbox middle and output shaft–frequency spectrums first stage gears misalignment

Second stage gears are working properly which is indicated by low amplitudes of GMF2.

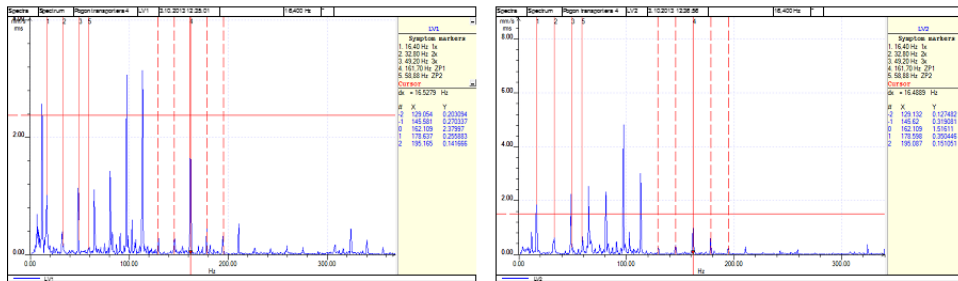
Driving unit 4 - When analyzing the frequency spectrum measured on electric motor it is clear that both parallel and angular misalignments are present as in the drive unit 1, as shown on Figure 13 and Figure 14.

Fig. 13 Drive unit 4 - LV1 and LV2 frequency spectrums – parallel misalignment

LV1 [mm/s]	LV2[mm/s]	LV3[mm/s]
1x - 16.4Hz	1.1	1.9	4.3
2x - 32.8Hz	0.2	0.5	0.4
3x - 49.2Hz	1.2	2.4	1.8

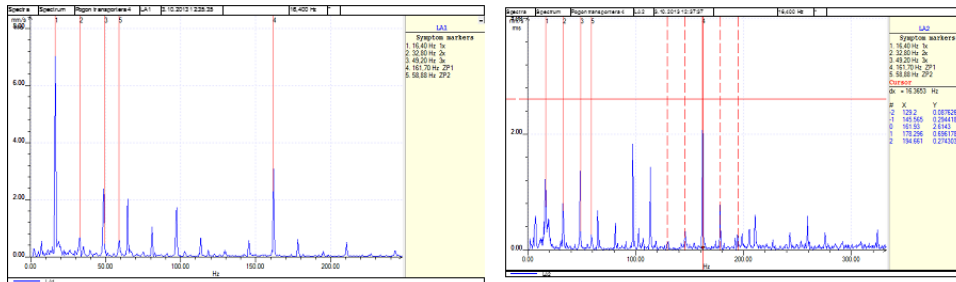
Fig. 14 Drive unit 4 - LA1 and LA2 frequency spectrums - angular misalignment

LA1 [mm/s]	LA2[mm/s]
1x - 16.4Hz	6,8	1,2
2x - 32.8Hz	0,8	0,8
3x - 49.2Hz	2,3	1,6

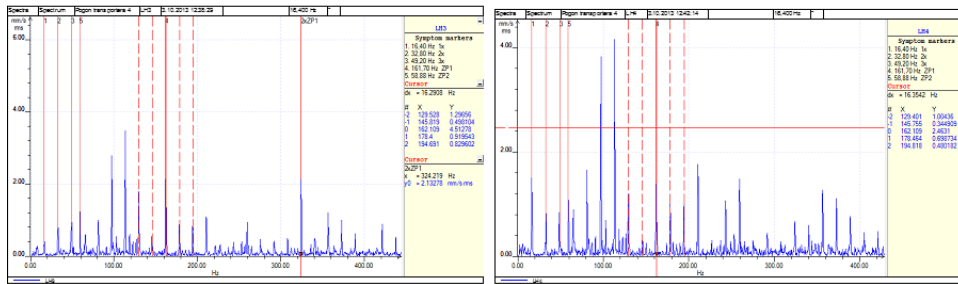
Frequency spectrums measured on gearbox indicate that higher vibration levels are caused by first stage gears tooth wear. This is determined by high amplitudes of first stage gear mesh frequencies harmonics – GMF1, GMF2 and GMF3 and surrounding sidebands.

LH3 [mm/s]	LV3 [mm/s]	LH4 [mm/s]
1xGMF1 - 161.7Hz	4.5	4.2	2.4
1xGMF sidebands	3.8	2,6	4,4
2xGMF1 - 323.8Hz	2.1	3.9	1.6
1xGMF2 – 58.88Hz	0.3	0.5	0.4

Fig. 15 Drive unit 4 - LH3, LH4 gearbox input shaft - frequency spectrums first stage gears misalignment + gear tooth wear

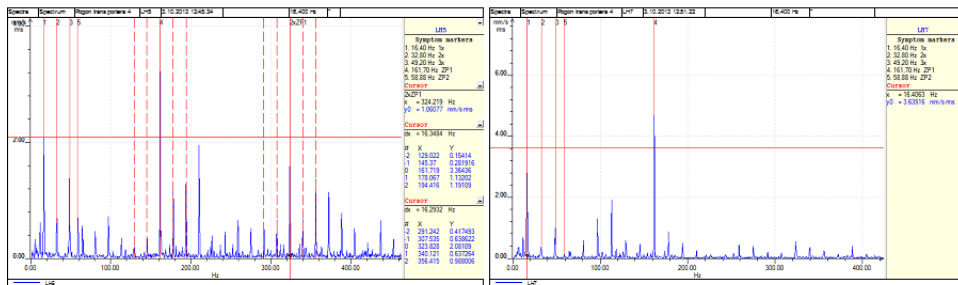
LH5 [mm/s]	LH6 [mm/s]	LH7 [mm/s]
1xGMF1 - 161.7Hz	3.2	6.4	4.6
1xGMF sidebands	1,2	0,8	2,1
2xGMF1 - 323.8Hz	2.1	1.1	0.4
1xGMF2 – 58.88Hz	0.6	0.5	0.3

Fig. 16 Drive unit 4 – LH5, LH7 gearbox middle and output shaft - frequency spectrums first stage gears misalignment

Second stage gears are working properly which is indicated by low amplitudes of GMF2.
