**THE SELAMLUK IN VRANJE, PART II
ARCHITECTONIC CHARACTERISTICS OF STRUCTURAL
AND DECORATIVE ELEMENTS**

Aleksandra Mirić¹, Nađa Kurtović Folić², Goran Jovanović³

Abstract. *The complex of the Pašini konaci in Vranje, was built in the second half of the 18th century, and it is composed of two buildings. The pasha used to reside in the Selamluk with his entourage, while the Haremluk was a residence of the female part of the family. Due to the continuing use of these two buildings, their architectonic characteristics and historical environment were preserved to a great extent. Nowadays, the Selamluk and Haremluk have been declared the cultural property of great importance for Serbia.*

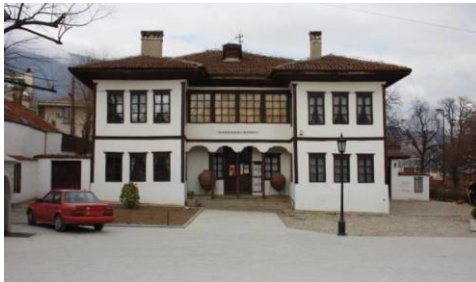
Fig. 3 South facade

The concept of spatial organization of the central plan is reflected in the composition of the main, south façade, which is completely symmetrical in relation to the vertical and horizontal axes, with the exception of the entrance section. The entrance is composed of two wing doors, geometrically divided, with the fanlight and one window on each side. Above the entrance, there is a façade bearing wall with four windows in a timber frame, which run along the entire length of the central hall on the first floor and provide bright illumination of the space. The windows have wooden muntins which divide the pane into nine small panes, which makes this part of the façade, with the entrance porch at the ground level, a very prominent central motif of the building front. On either side of the setback central part, with the entrance porch at the ground level and glazed wall on the first floor, there are shallow wings with the rooms. At the ground and first floor, there are three windows. Above all windows, having two wings and being divided into three panes, there are flat boards covering the lintel, covered by the simply profiled fillets. The full symmetry also characterizes the lateral, east façade, which has narrower setback central part accommodating the hearth room. In that part of the façade, there are two windows at the ground level and the floor. On the wings, there are three windows constructed in the same way as the front ones. Up the north façade, and projecting outside the layout of the façade, there is a chimney with two ducts, *kafe-odžak*, of the north east rooms. At the level of plinth on the north and west façade, there is a discreet difference of the horizontal level in relation to the wall plane (Fig. 3- 6).

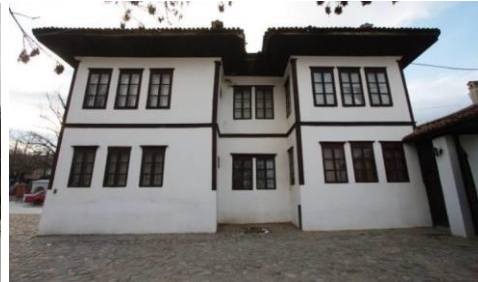
Fig. 4 East facade

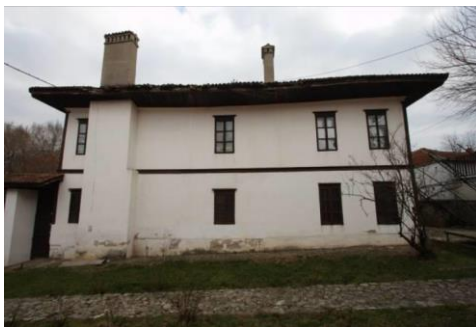
Fig. 5 North facade

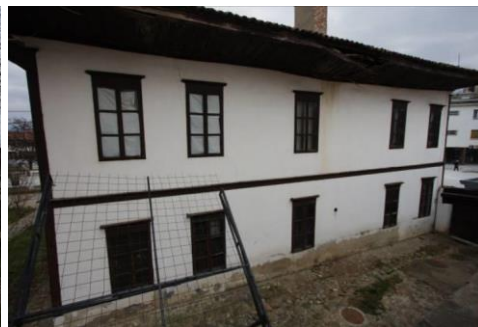
Fig. 6 West facade

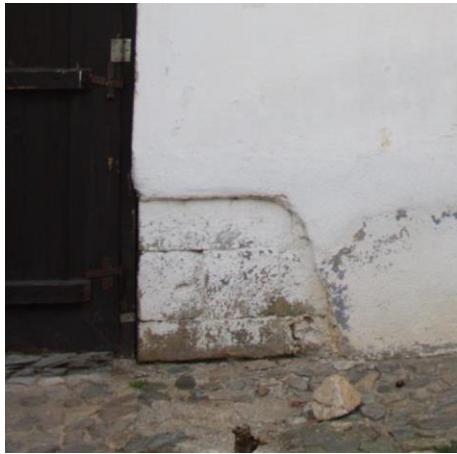
Fig. 7 Dressed stones, ground level

The foundations are made of stone, and the visible part of stone structure elevated about eighty centimeters above ground is made of regular dressed stones (fig. 7). Foundation beam, a timber beam laid along the foundation wall has the assumed cross-section dimensions of 17x17 centimeters and it is used to receive the load from the post-and-pan structure and redistribute it along the foundation zone. The joint of two foundation beams at the corners is mainly overlapping. The posts are fixed into the foundation beams by pegs. At the corners of the building, the posts were externally masked using decorative boards.

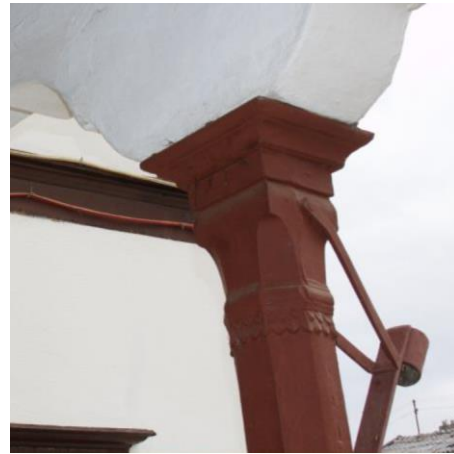
Fig. 8 Post detail

posts were doubled, both for the mutual proximity of the openings and for the reasons of reinforcing the doors and windows structure. The posts on the porch have at their tops a shape resembling a capital, decorated with carved leaves of simplified geometrical form (Fig. 8). The photograph taken during rehabilitation of the west facade wall in the 70's of the 20th century, published in the first part of this paper, one may observe the timber cushions (short timber beams) where they are joined with the timber caps (see: A. Miric, G. Jovanovic, N. Kurtovic Folic, *Selamluk in Vranje, Part I, Architectonic form development based on historical sources*, Fig. 10).

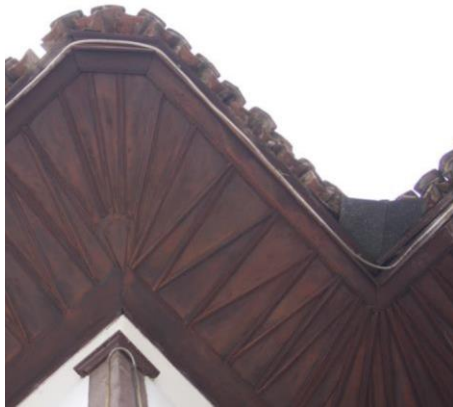
Fig. 9 Detail of eaves

The 1m wide eaves have the function of protecting the facades from the weather because of the lack of gutters. The rafters of the eaves are covered with the boards fitted at a right angle to the façade. The joints of the boards are sealed with the fillets, similar to the

way it was done in the interior, on the ceilings. At the corners of the building, the eaves are truncated (Fig. 9).

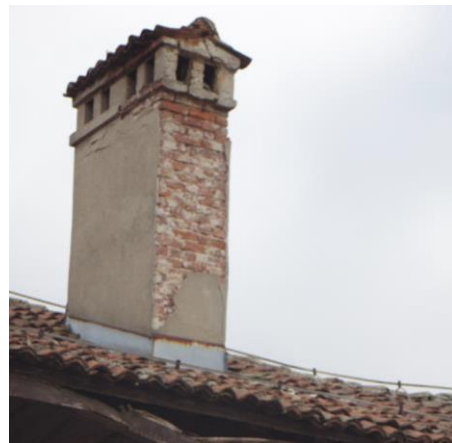
Fig. 10 Chimney

The chimneys are made of bricks, and the chimney caps are made as gable roofs covered with Turkish tile (Fig. 10).
