DEGRADATION OF ARCHEOLOGICAL SITES – CASE STUDY CARIČIN GRAD

Abstract. *Archeological sites, as highly complex parts of the cultural heritage, require special care in all parts of planning, research, conservation and presentation. An archeological site, from the moment of excavation and further on, is permanently exposed to external, potentially harmful conditions: starting from structural problems during excavations, and exposure to atmospherics (rain, frost...). Influence of vegetation on site degradation cannot be neglected, as well as influence of people. All the mentioned factors that influence degradation of archeological sites are classified in this paper and presented through an example of the Caričin Grad early Byzantine site located near Leskovac in Serbia.*

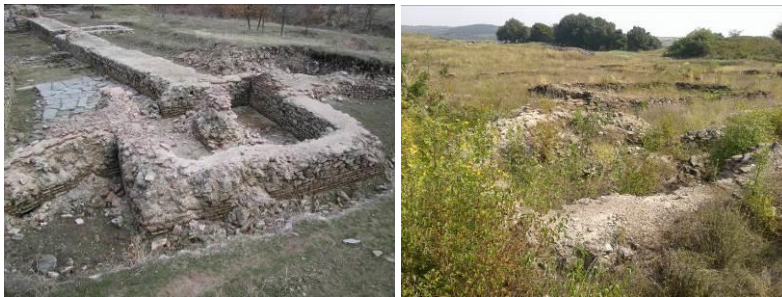
One of the biggest problems of this site is lack of coordination of archeological and conservation activities. Because of lack of following the archeological excavations with appropriate conservation works at Caričin Grad site, the explored structures are in a very poor condition. Even the conserved structures, due to exposure to weather and growth of weed over years, sustained severe damage. (see Fig 4)

Fig. 4 Southwest corner tower of Lower Town within a span of several years (photo: A. Momčilović-Petronijević)

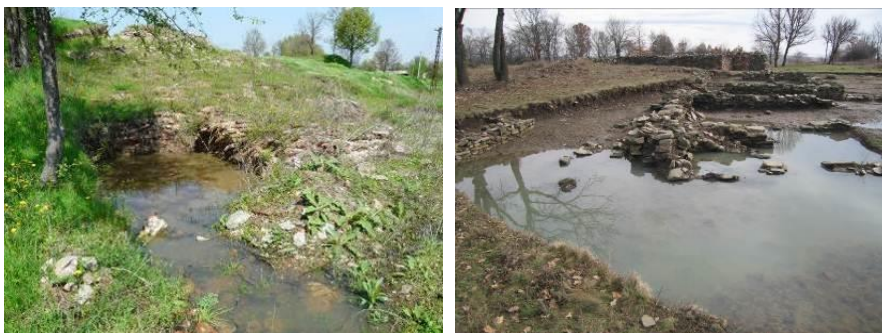
After excavation, the structures are not immediately conserved, or at all. A large problem at the site is precipitation water which accumulates in the pits and depressions created by archeological excavation (see Fig 5). In autumn and winter, water pools around the walls due to poor draining. Several freeze-thaw cycles results in damage, first of the mortar, and later on bricks and stone.

Fig. 5 The problem of precipitation water during archeological excavations (photo: Č. Vasić)

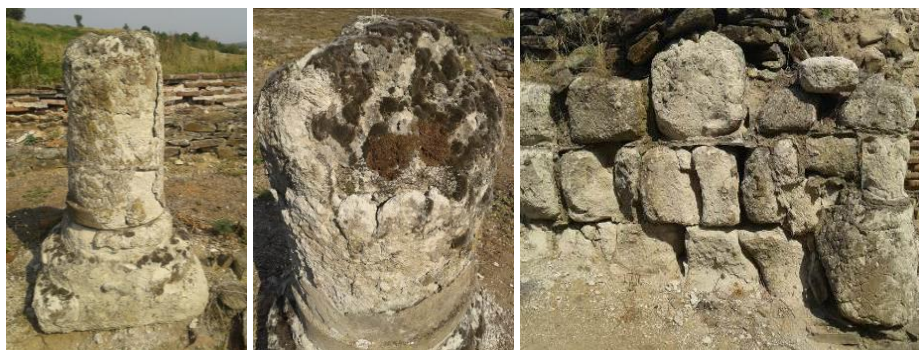
Durability of stone structures at the site depends on the type of stone, but also of a number of various factors. Poor bricklaying technique on certain locations resulted in swelling and falling off of the wall core. Degradation of stone on at the archeological sites was most frequently connected with porosity and lack of stone resistance to frost. The stone develops cracks and fissures, mostly due to weathering. Flaking and crumbling from the surface inwards depends on the natural defectiveness of the stone. A special problem on the surface of stone plastics, in addition to the previously mentioned damage, is formation of a film due to chemical action of salts and other agents (see Fig 6).

Fig. 6 Stone damage: flaking and crumbling
(photo: A. Momčilović-Petronijević)

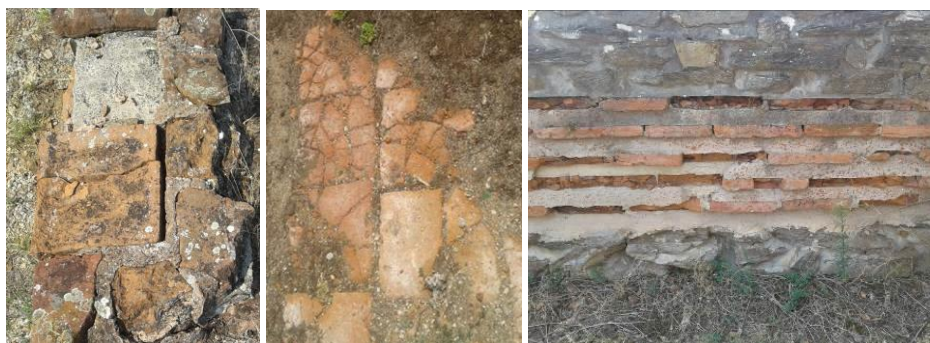
Damage on the bricks is most frequently mechanical: disintegration, crushing due to the topsoil weight, due to the fall of structural parts. There is also damage incurred by the cyclical frost and salt efflorescence on the brick surface (see Fig. 7)

Fig. 7 A detail of brick pavement – the brick is cracked (left);
poor quality bricks used for conservation
(photo: A.M.Petronijević)

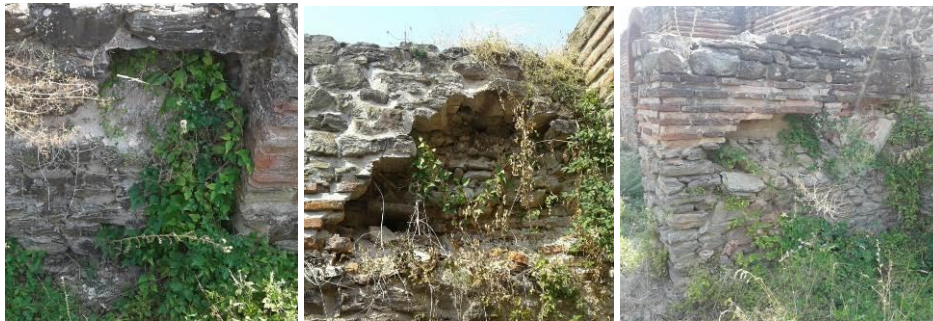
loses its binding properties in the period while the structure is still buried under the soil. The moment it is excavated, the mortar is exposed to drying, that is to the dampening and drying cycles, freezing and thawing which causes the highest level of degradation. The mortar crumbles, and the bricks or stone blocks which were bound with it fall out of the wall (see Fig 9 and 10).

Fig. 9 Open caverns in the massive fortification walls
(photo. A.M.Petronijević)

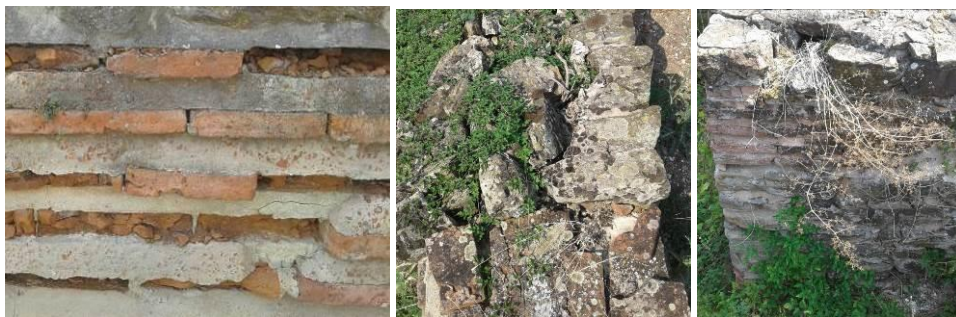
Fig. 10 Degradation of bricks, and mortar after conservation
(photo. A.M.Petronijević)

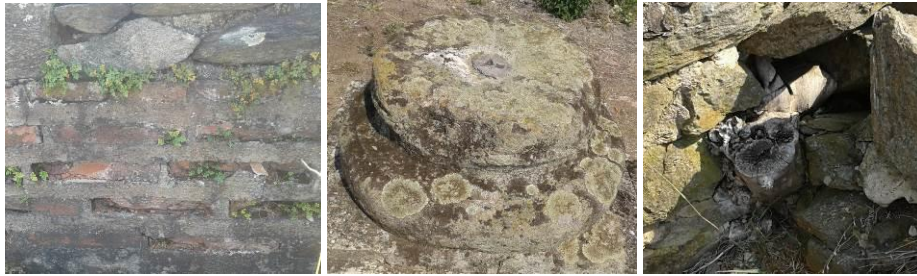
Biodegradation is also not negligible. The excavate parts remain in the open, so in time moss and lichen attach to them, and also the get covered with grass and shrubery whose root systems additionaly degrade the structure. The plants roots penetrate the wall structure and exerts pressure on the stone and bricks (see Fig 11).

Fig. 11 Vegetation in the damaged bricks (left); lichen on the parts of a stone plastics (middle); cut tree at the base of the wall (right)
(photo: A. M. Petronijević)

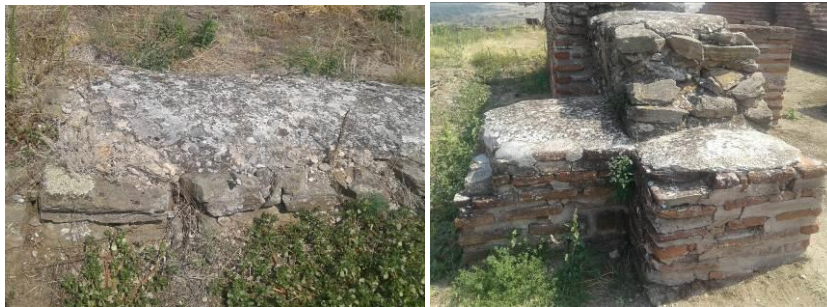
Usage of incompatible materials used for conservation, such as concrete caps with brick walls, was a common practice of the first conservation activities. (see Fig 12) Time has shown that this is not the best solution. The water from the caps, which are less porous than the original matter, trickles down the walls and damages the mortar and bricks. The cement mortar which was used is stronger than bricks, which causes wear of material in the immediate contact, due to strong micro-pressures of mortar on the surrounding materials. [19] The mortar used for restoration and conservation should contain a low level of salt, and it should be as similar as the original material as possible, regarding its mechanical, chemical and structural characteristics.

Fig. 12 Inadequate concrete “caps”
(photo: A. M. Petronijević)

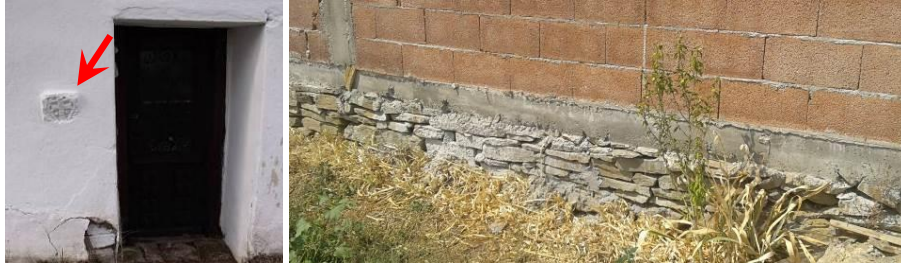
The local population also contributed to the degradation of the structures of the Caričin Grad site, since it used the ruins as a free quarry of construction material. For instance, in the St. Ilija church, whose layout belongs to the 15th century churches, and whose foundations were used for construction of new church, there are a lot of pieces of stone plastics taken from Caričin Grad. The large alter is, in fact, the base of a column, and Justinian capitols were built

into the wall. Even now, one can see the ancient bricks or capitols or column bases built into the local houses, fences, stables and other buildings. [1] (see Fig 13)

Fig. 13 a) Pieces of stone plastics from Caričin Grad built into St. Ilija church
(photo: Institute for Cultural Heritage Preservation of Niš),
stone from the site built into the foundations of the walls of surrounding buildings
(photo: A.M.Petronijević)

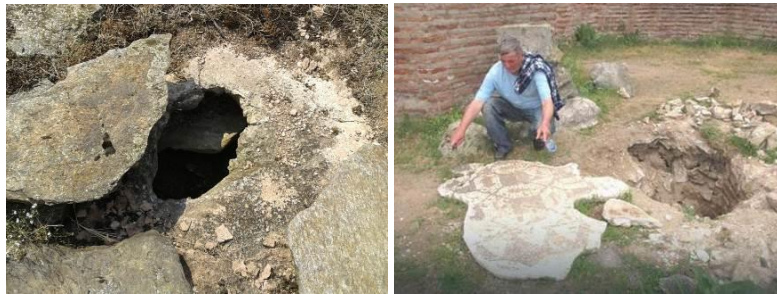
There is also frequent evidence of physical degradation caused by action of quasi-archeologists or gold diggers, who dig the site with no regret, while looking for the precious objects. The freshest case dates back to 2010 when these diggers destroyed a part of conserved mosaic in the baptistery looking for riches. The solution of this problem is in raising awareness of people about the importance of this form of cultural heritage and employing of a security person at the site.

Fig. 14 Illegal diggers looking for gold at the site (left: photo A.M.P, right
<https://www.blic.rs/kultura/vesti/strogo-zabraniti-detektore-metala/s5m16zb> (sept., 2017))

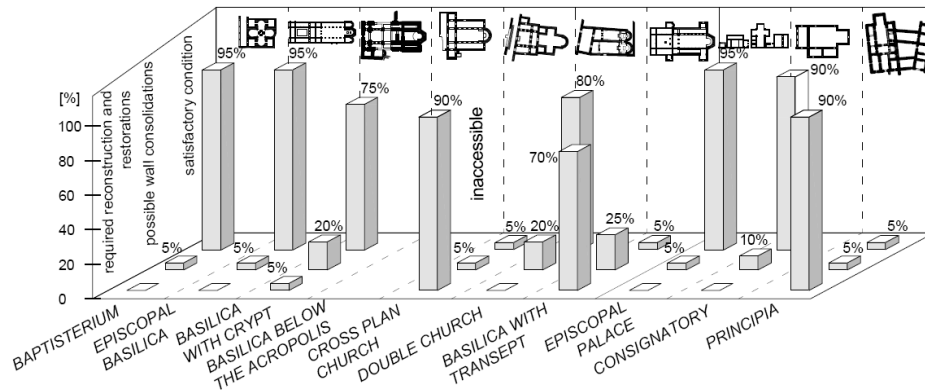
As it was previously said, the conservation activities at Caričin Grad have been conducted on slightly more than on 1/3 of explored structures, but due to the irregular maintenance and lack of conservation activities, only around 15% of site can be considered to be in good condition. From the graph (see Fig. 15 and 16) it can be concluded that the structures and fortifications of the acropolis are in presentable state. Simultaneously, those are structures which were conserved, protected and/or reconstructed in good time. By a comparative chronological analysis of the documents of the Institute of monument protection of Niš on Caričin Grad, and based on the assessment of the condition of wall masses at the site, it can be concluded that occasional, belated and partial interventions did not yield satisfactory results. After archeological excavations of: cruciform church, basilica with transept, principium, villa urbana, thermae aetc, there was a

number of years of total negligence. This resulted in an extremely poor condition of the most part of wall masses of these structures. Further conservation and protections is almost not possible any longer, and the mentioned structures call for significant reconstruction works.

Fig. 15 Assessment of the condition of wall masses on the individual structures in Caričin Grad (drawing P.Petronijević)

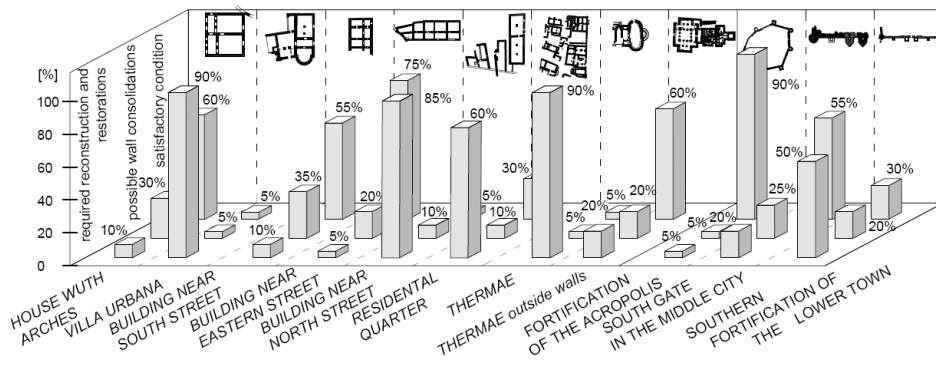
Fig. 16 Assessment of the condition of wall masses on the individual structures in Caričin Grad (drawing P.Petronijević)
