## COLLISION OF BUILT HERITAGE REVITALISATION PRINCIPLES AND “DESIGN FOR ALL”

**Abstract** *Nine briefly examined examples of built heritage in this paper reveal various cases of collision of conservation principles with demands of barrier-free architecture. The importance of this issue has been raised in the light of increasing world-wide efforts to preserve cultural heritage buildings for future generations by revitalization and strong efforts, in particularly in the EU, to reach higher standards in inclusion of all social groups.*

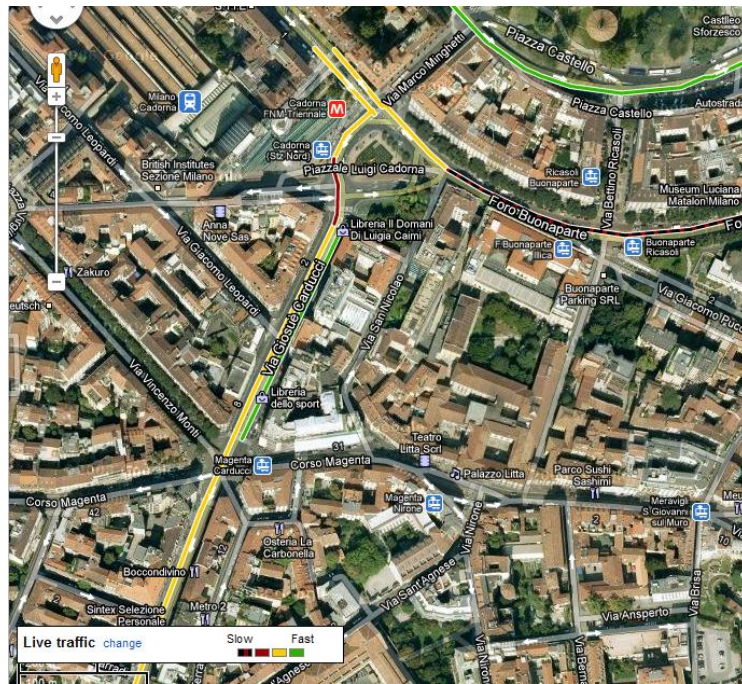
**Fig. 1** Photography from the air of Milan-Arese Litta Palace with marked traffic frequency in the surrounding streets [18]

The spacious complex within the former medieval town is situated close to the major roads. Nowadays, there is no parking space in front of the main entrance on Via Magenta, basically due to changes in street regulation which were created to meet needs of traffic which increased in speed and frequency. Originally, the street was integrated with the square (Fig. 2). On the eastern side of the complex, there are about 25 parking places. The main entrance to the theater remains the one from the garden, with access from Foro Bonaparte (Fig. 3).

Example 3.2.1 demonstrates the difficulty in accessing cultural property which is in the nowadays found in densely built environment with heavy traffic, which made it impossible to provide parking in front of the main entrance. From the point of accessibility, it is important that the distance between the parking area and the entrance is as little as possible. In the case of Arese Litta Palace, the main entrance to the cinema (as an illustration of the content of public use) is set on the garden side, in order to, among other things, reduce the distance between the parking places, provided for vehicles accessing from direction of Foro Bonaparte, and entrance to the building. Replacing the functions of the main entrance violated the recommendation that facilities must be simple and easy to read. Without previous knowledge of the position of the entrance, it cannot be logically assumed based on the architecture.

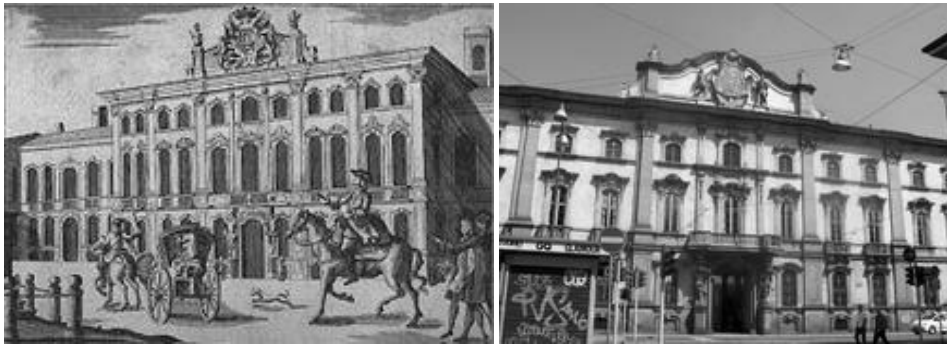
**Fig. 2** The main entrance to the palace Arese Litta in the XVII and XXI century, respectively [16]

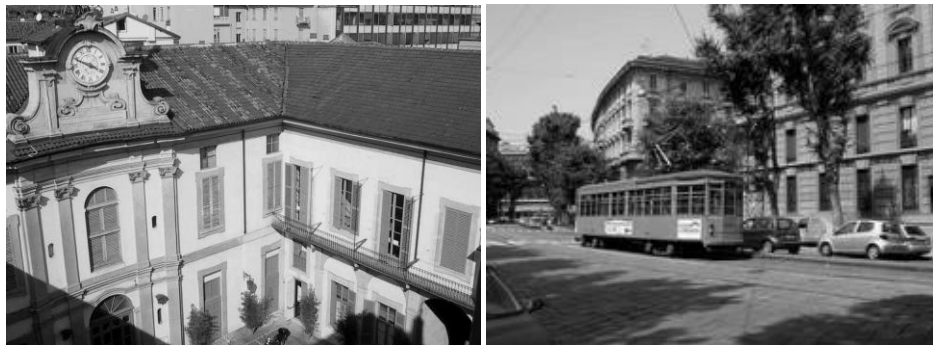
**Fig. 3** The entrance to the palace Arese Litta from the garden and driveway from Foro Bonaparte, respectively [16]

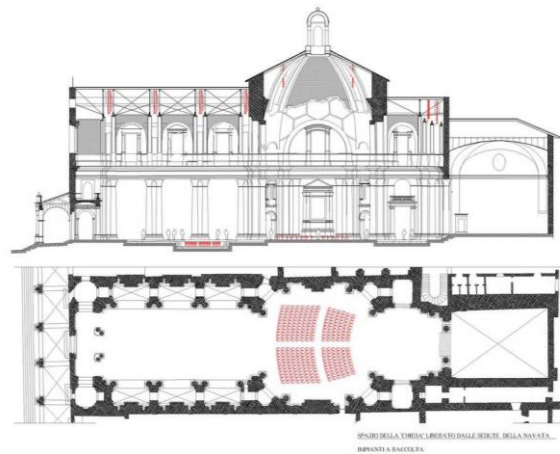
**Fig. 4** Section and ground plan of the church St. Maria in Gradi [6]

The interventions consist of consolidation, construction of a new roof and reinforcement of the structure, in order to allow reuse of inner space as multifunctional auditorium and conference hall for the University of Tuscia. The façade of the church has suffered significant changes, already during Renaissance renovation of architect Nicholas Salvi, and then several times in the modern era [6]. Evidently, the architect retained the main entrance staircase, which dominates the appearance of the front, in its original form (Fig. 4-6).

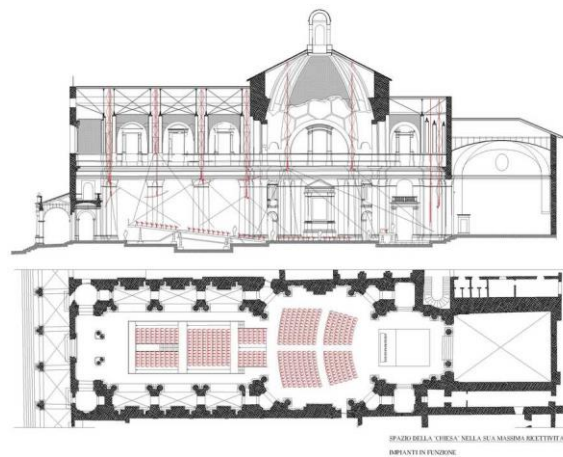
**Fig. 5** Sections of church of St. Maria in Gradi reutilized as conference hall [6]

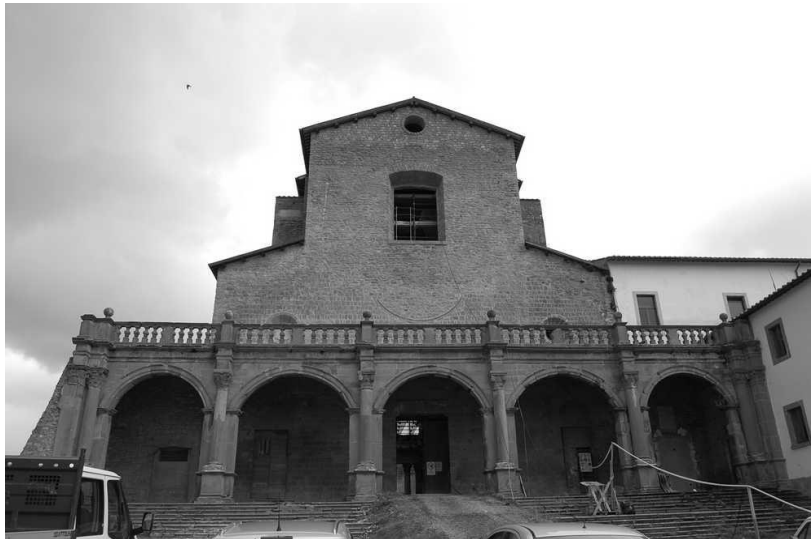
**Fig. 6** The front of the church of St. Mary in Gradi during reconstruction [6]

The ramp in Fig. 6 was only temporally, therefore there is not a permanent access for people with reduced mobility, at front. The main entrance does not meet the criteria of "accessibility for all", since it is not at the level of the street, neither the staircase itself, without armrests, fences, entrance ramps, auxiliary lifting platforms, and without contrast between the stairs and walkways, nor highlights at the beginning of the stairs, in color or by tactile or visual processing. When it is not possible to ensure that all horizontal and vertical communication paths fulfill the principles of design for all, it is considered acceptable to provide at least one. Such is the case with St. Maria in Gradi, with the more convenient access, at the other side of the building.

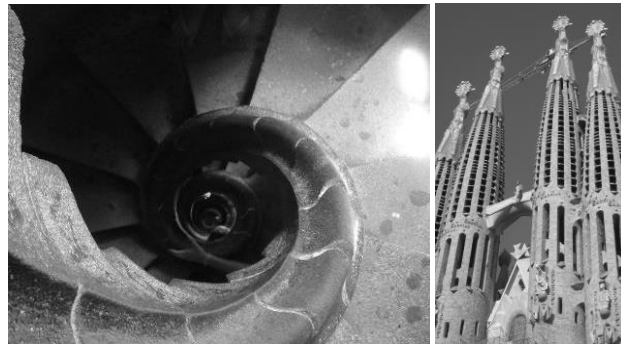
**Fig. 7** Staircase and the tower of the church Sagrada familia in Barcelona [22]

Figure 7 (on the left) presents well-known view to the stairs (example 3.2.3) in one of the towers of the church Sagrada Familia, in Barcelona, which reveals serious issue of people with impaired mobility. Neither of narrow spiral staircases, within each of the towers (with distinctive perforated outer wall, shown on Fig. 7 on the right), have railings nor handrails, and basic safety is evidently not ensured.

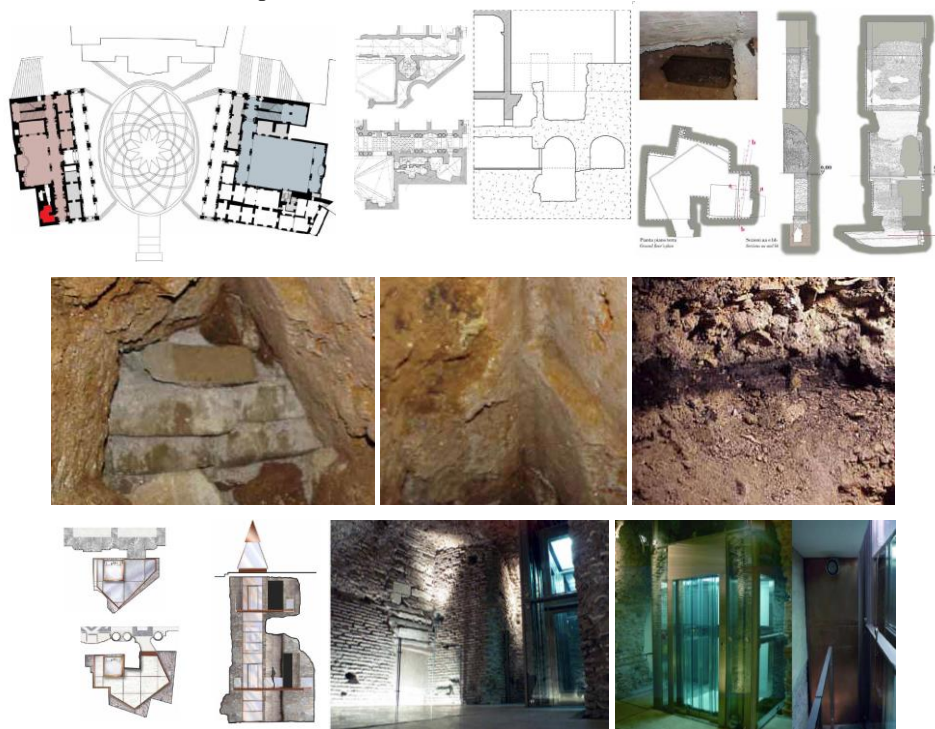
**Fig. 8** The elevator the Capitoline Museum - Campidoglio in Rome: the situation, the location of the elevator, photo during construction, base and cross section, layers of the ground, layout drawings and outcome [2].

The construction of the elevator in the Capitoline Museum (Palazzo di Nuovo) in 2003 in Rome (example 3.2.4, Fig. 8) required cutting through several layers of brick, Roman concrete, stone and earth [6]. The principle of one route for disabled was consistently applied in the Capitoline Museum, in which modernization of vertical communication was considered a necessity. In this case, an elevator with folding doors, and automatic initiation mechanism of opening was built in. Using panoramic elevator is an interesting choice, because it made visible all the archaeological layers, which were cut through during the construction.

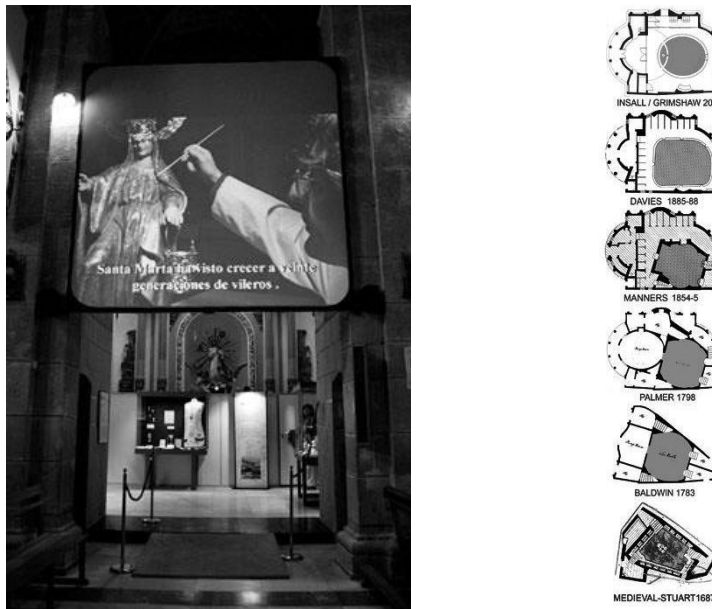
**Fig. 9** (on the left) The corridor in the Municipal museum of Villajoyosa [29];  
(on the right) Ground plans of Roman bath in Cross-Bath, through history [5].

Example 3.2.5 displays the setting of the exhibition about St. Marta in Villajoyosa, near Alicante, at the Municipal Museum building (2003) (Fig. 9). The building was converted into an archaeological museum in 1995. Difference in height, which appears frequently in buildings reused for another purposes, has been resolved by a ramp [26]. However, the ramp is not as wide as the corridor. This example also illustrates the use of audio-visual information for cultural purposes, in a manner that suits wide audience, including people with disabilities of various kinds.

Example 3.2.6 shows the atrium of a Roman bath in Cross-Bath (UK), reconstructed for the sixth time in 2003 (the previous reconstructions took place in 1687, 1783, 1798, 1854/5 and 1885, see Fig. 9 on the right). The wall between the corridor and atrium has been built of transparent glass. The outline of the building, as well the material and the form of outer walls have been preserved (Fig. 9 on the right and Fig. 10, on the right) as reconstructed in 1798, with the exception of the entrance [5].

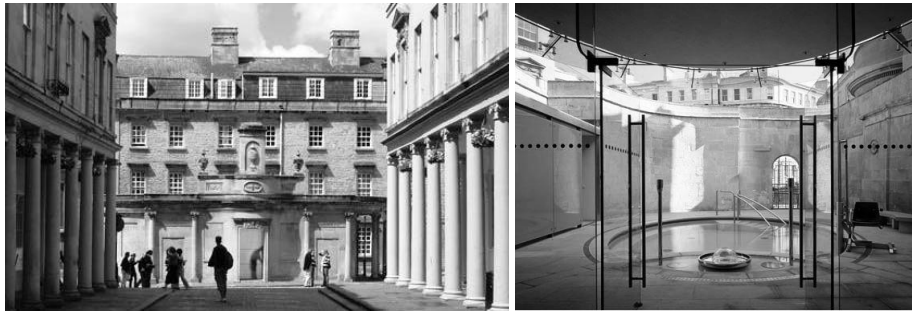
**Fig. 10** The main entrance of the bath, (on the left) and atrium pool (on the right) in Cross-Bath [5]

Due to lack of authenticity of interior, lost in frequent reconstructions, continuity with the past is provided in an unchanged purpose of the building. Such circumstances widely opened an opportunity for substantial use of modern materials and technologies in the interior. However, glass walls are not considered appropriate choice for many groups of disabled, and in particularly those with impaired vision. Also, vehicular access and parking area were not and could not be provided near the main entrance. Finally, the modernization of the interior in this example is believed to prolong life of the building and limit accessibility for many.

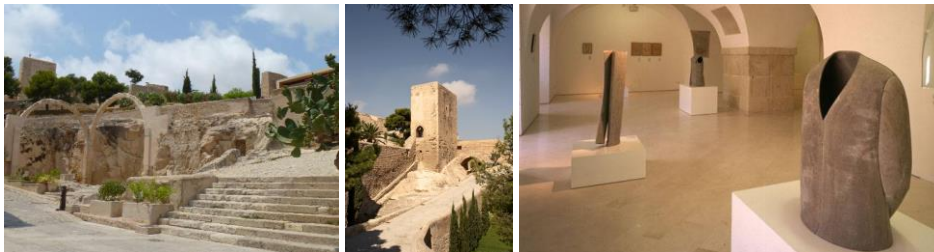
**Fig. 11** External stairs, ramp and exhibition hall, fortress of St. Barbara, Alicante [1]

Next example (3.2.7) presents several issues regarding accessibility in fortification of St. Barbara, in Alicante. It was built of rock from the site, which was considered very practical, *inter alia*, for the reasons of defense and frequently applied in the Middle Ages, for strategic reason. Therefore, original colors and materials of walls, pavement, exterior stairways, railings, ramps, etc. match the natural environment (Fig. 11). For the same reason, the color of the floor and the walls in the interior are identical. However, nowadays, rooms are reutilized as exhibition halls [1], and criteria of desired processing changed, questioning if it meets needs of design for all. In this example, the ramp does not meet safety requirements (Fig.11), neither in the exterior nor the interior; contrasting colors in order to facilitate the access of persons with visual impairments were not applied. On the other hand, using the same material for the walls and floors is authentic and important for understanding the characteristics of the original concept of the fortification. However, one route for all is provided - there is a back entrance and an elevator that leads from the base to the top of the fortress.

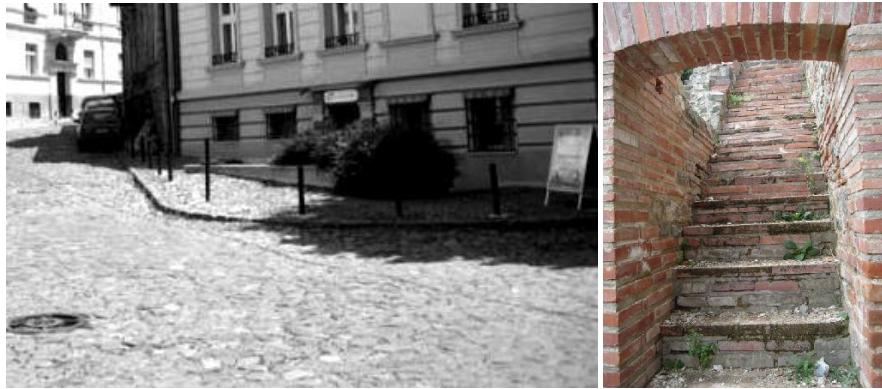
**Fig. 12** (on the left) Kosančić wreath in Belgrade [12] (on the right) Staircase in Felix Romuliana, the archeological site [8]

Example 3.2.8 refers to Kosančić wreath in Belgrade. The photo shows characteristic of street surface and inadequate parking space within the street regulation (Fig. 12, left). The street surface at Kosančić wreath, which belongs to the spatial cultural and historical entity of great importance, is considered very important and that it contributes immensely to preservation of authenticity of the nineteenth century Belgrade.

The stairs (Fig. 12 on the right) have been made entirely of brick. Foreheads of the steps are flat and there are not tread moldings. The staircase is not equipped with handles or railings. Although the staircase is a reconstruction, they were made according to assumptions without any concern for requirements of access for all. The concept of brick stairs would be changed if handrails, step molding, contrast etc. would have been added. Possibly, original walls will suffer certain damage.

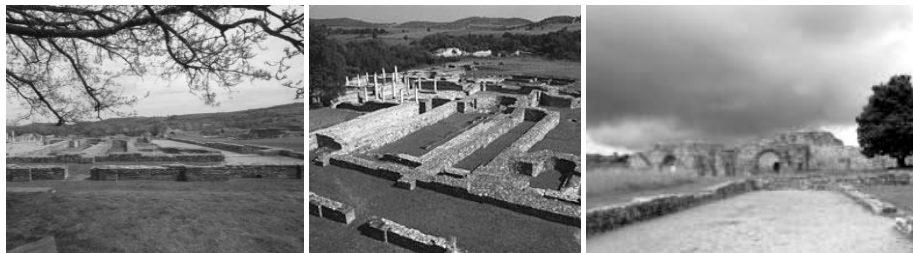
**Fig. 13** Archeological site Felix Romuliana, near Gamzigrad [8, 9 et 10]

Example 3.2.9 shows Felix Romuliana remains of fortified settlement built by Roman Emperor Galerius (fig. 13). The access paths of this archaeological site near Gamzigrad, Serbia mostly have grass, gravel or earth surface. For accessibility, it is essential that the surface is flat, firm and slip-resistant. This is not the case in this example, or in the previous one.
