FACTA UNIVERSITATIS

ARCHITECTURE AND CIVIL ENGINEERING

Vol. 19, N° 3, 2021

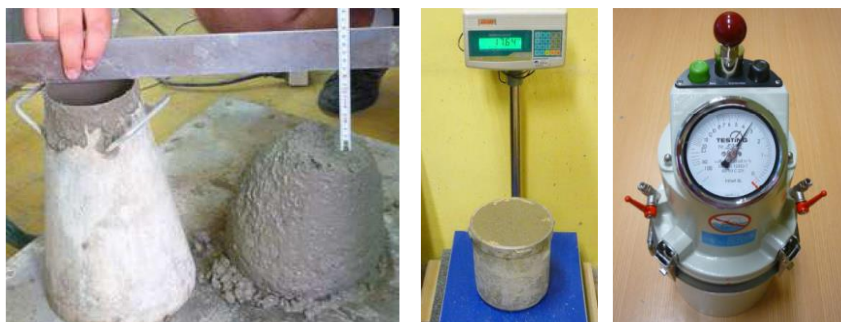
Air content test: This test was performed in order to determine the percentage of air drawn into the fresh structure of concrete (Figure 3 - right). The test was conducted according to standard SRPS EN 12350-7:2010. In this case the porosimeter of vessel density was used.

Fig. 3 Testing the fresh concrete properties: Slump test (left), Density test (middle), Air content test (right)

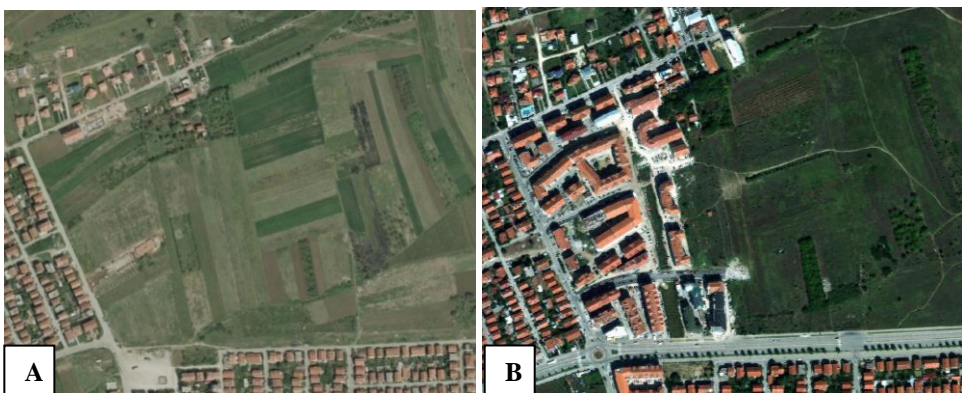
Fig. 2 Type of multi-family housing: Multifamily housing on greenfield locations on the outskirts of the city – the layout of housing area Somborska-Studenička. A - 2006 (source: <https://gis.ni.rs>, accessed 2019); B - 2021 (source: <https://a3.geosrbija.rs/>)

The following section deals with multifamily housing on greenfield sites on the outskirts of the city as one of dominant post-socialist housing development types. Although similar to socialist large housing estates, it originated under modified conditions in post-socialist period, which resulted in specific physical-functional features. Shaped by private capital from the very beginning, accompanied with poor planning and weak institutional control, it represents a typical example of what is better known as “investor urbanism” [26].

The violation of planning rules was not an individual phenomenon, but a common practice in development of Somborska-Studenička. Although it was previously planned as low-rise housing (max. number of floors GF+4), the current state in the area indicates a different development. The most common deviations include:

- congestion of space caused by high occupancy level, building density, exceeded object height and insufficient distance between buildings;
- space fragmentation and absence of spatial integrity;
- lack of open /green space (public and private);
- poorly designed pedestrian and vehicle traffic patterns;
- lack of basic public services.

The analysis of the Somborska - Studenička housing area, showed that physical and functional structure of the area is largely a result of systematic violations of building rules set in planning documents, as well as deficiencies of planning documents. Investor-driven development resulted in spatial and functional fragmentation of space, loss of open and green areas (both public and private), lack of basic public services, pedestrian inaccessibility and congestion of space, affecting the quality of life of residents at the neighborhood level.

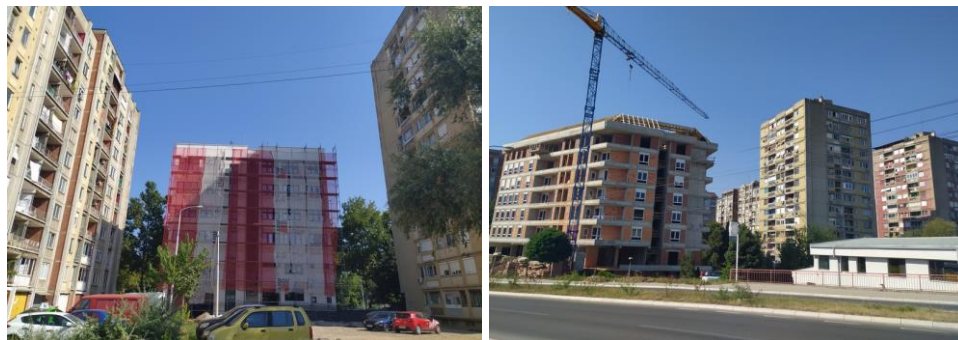
Fig. 3 Type of multi-family housing: New infill development - LHE Bulevar Nemanjića (source: authors)

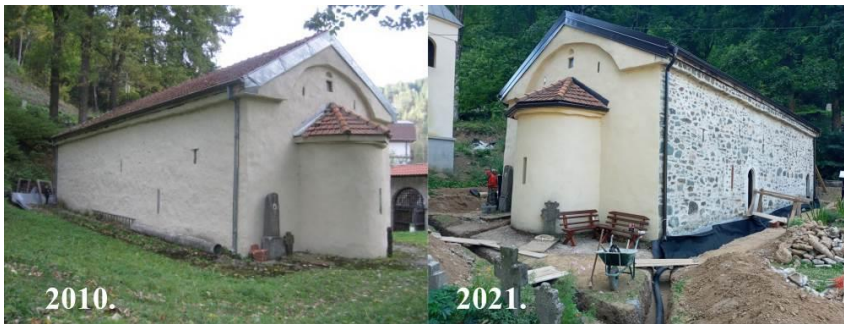
Fig. 1 The St. Nicholas church in Crna Trava (photo: P. Petronijević)

During 1989, in addition to probing archeological works, works on cleaning the facade, making part of the sidewalk, reconstruction of the roof cornice were carried out, and the roof covering – ceramide was partially renewed. In the stage of works in 1990-1991, inadequate and subsequently added arches and pilasters in the narthex were removed, braces were added in the upper part of the building and thus static strengthening of the upper structure was performed, facade and window openings were treated, gutters were installed, sidewalk on the west and south side, a protective retaining wall on the west and part of the south side, as well as part of the fence wall on the southeast corner of the complex were constructed. During the stage of works in 1991-1993, the complete fence wall, entrance gate was completed, part of the gate along the fence wall was leveled, the portal of the southern door of the nave was reconstructed, and the entrance door of the church was made [1, 3].

Twenty years after the last works on the church, since 2012, works on the building have been carried out again, this time without cooperation with the competent Institute for the Cultural Heritage Protection. The roof was renovated, then the floor and the iconostasis, the openings were glazed, a new chandelier was installed, as well as the necessary inventory for the service. Since 2012, the church has been in function again. In 2020 and 2021, rehabilitation works were carried out to solve the drainage of water around the church (Fig. 1).

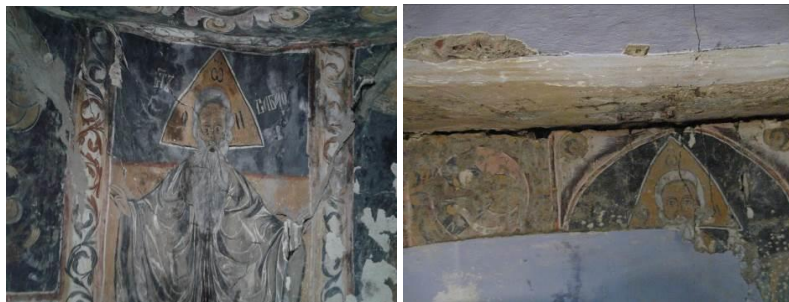
The characteristic of stone masonry vaults is low tensile strength due to low tensile strength of the mortar and insufficient bond between the stone and the mortar [9]. The tensile strength of the vault depends on the type and quality of the mortar with which it is built, as well as the porosity, surface roughness of the stone and the geometric relationships of the stone used for masonry. The compressive strength of masonry vaults is considerable. Although local stone crushing can theoretically occur, global failure due to pressure is unlikely, because the compressive stresses are negligible in relation to the compressive strength of the vault. The cracks in the vault were created by the action of edge tensile stresses caused by bending (Fig: 4). The cracks extend mainly through the mortar and through the joints of mortar and stone.

Fig. 4 Cracking in the barrel vault of the st. Nicholas church, (photo: P. Petronijević)

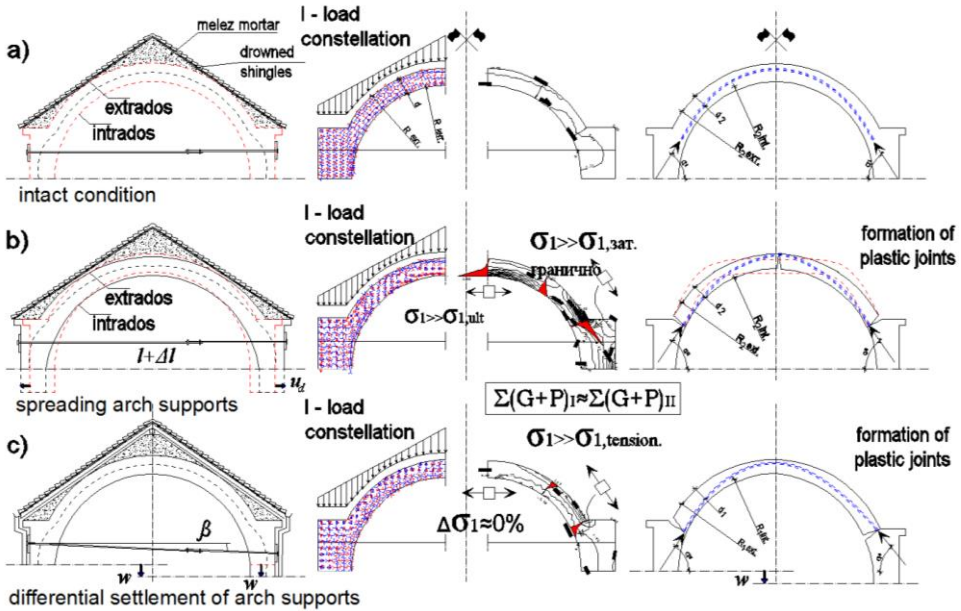
Fig. 8 The influence of wall spacing and different settlement of supports on the change of stress state and the mechanism of vault fracture [3]

the longitudinal walls. Anchoring was realized with two steel members (see Fig. 7-b) in inadequate places, one brace even passing through the window. Anchoring did not include base plates so there is no possibility of subsequent force correction by increasing the tension. Arched structures are extremely sensitive to the spacing out of the supports. Braces failure and the walls spacing out at the height of the cornice by only 0.1% of the vault the span, increases the tangential tensile stress in the apex and the arch support several tens of times. This exceeds the tensile strength of the mortar multiple times, cracks and fissures occur and the supporting line of the vault is deformed depending on the number of newly formed plastic joints (see Fig. 8-a).

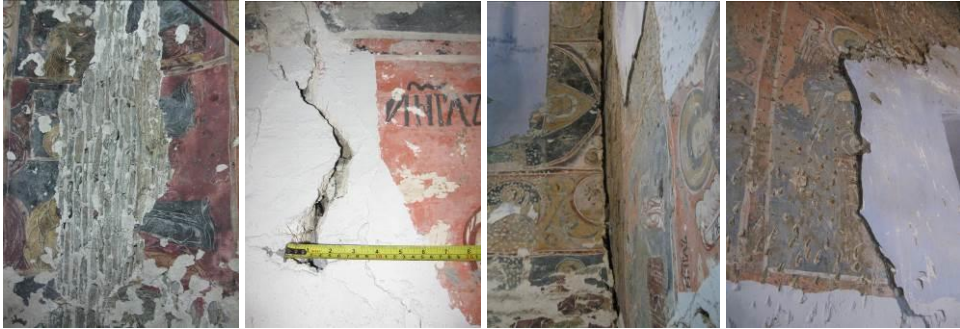
Fig. 9 characteristic cracks between the vault and the transverse walls (photo. P.P.)

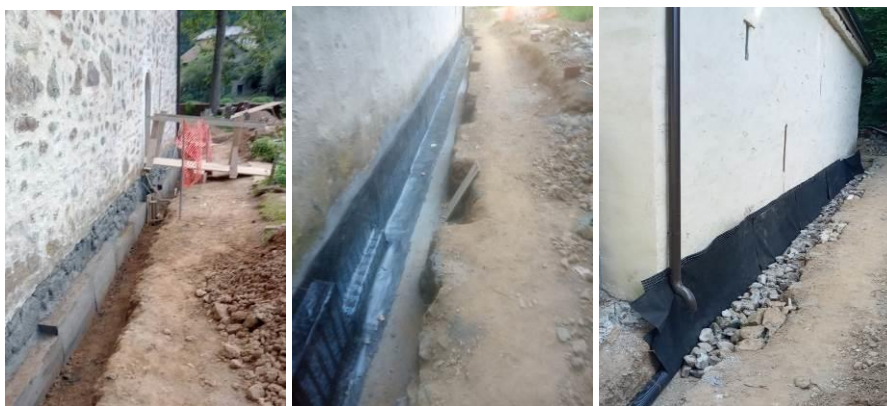
Fig. 13 a) reconstruction of the plinth wall, b) hydro-isolation, c) drainage (Photo P.P.)

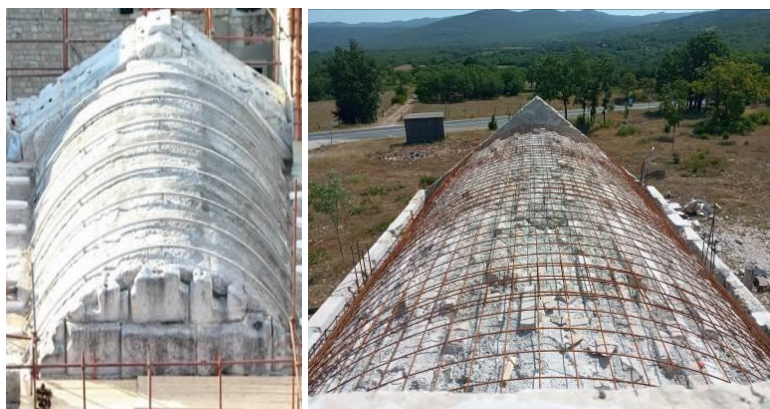
Fig. 15 a) Reinforcement of the vault extrados with steel arches, b) masonry vault reinforcement with additional RC vault (photo: P.P.)

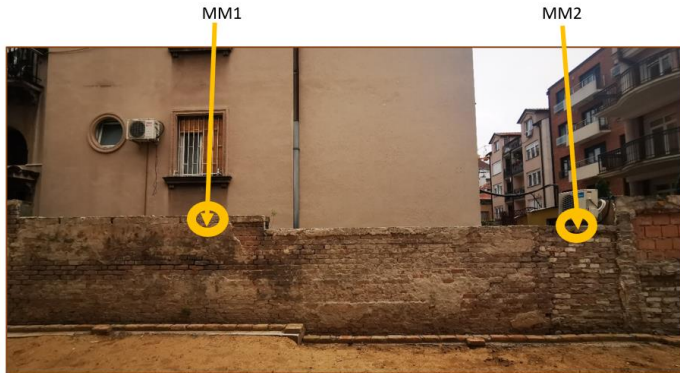
Fig. 5 Photograph of the wall separating the plot of the business building and the plot of the neighboring residential building; the positions of the measuring locations places are marked (view from the side of the office building)

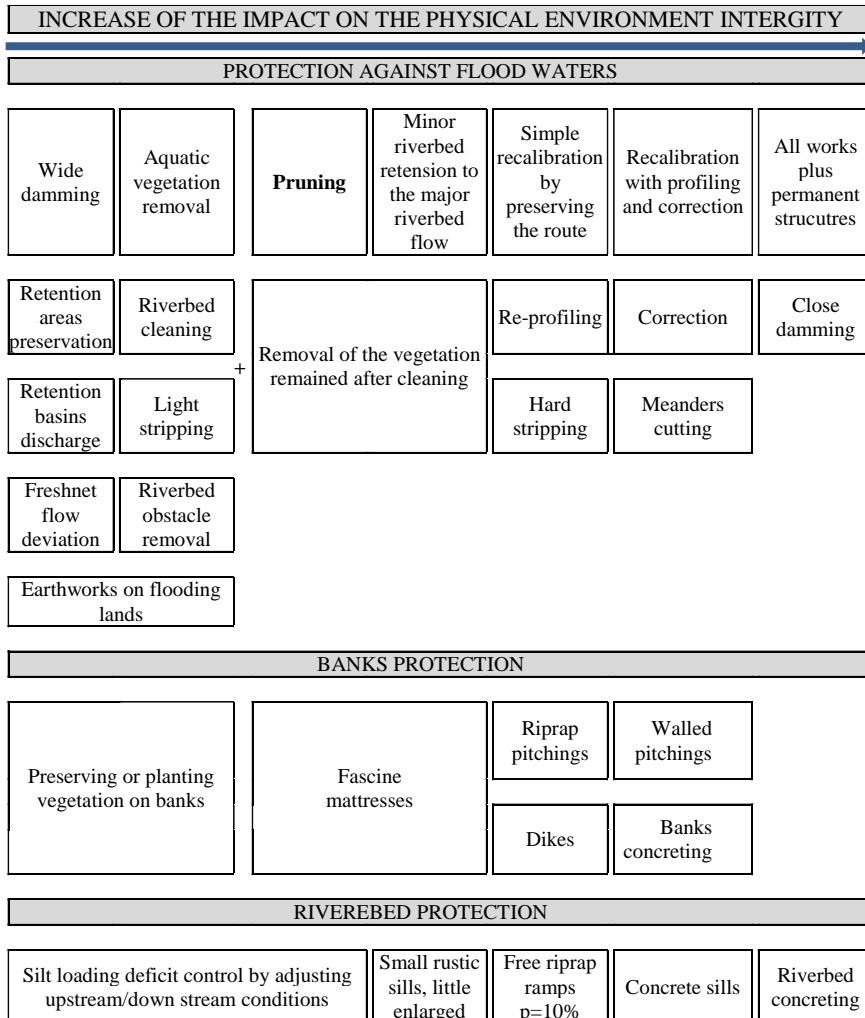
Fig. 2 Main types of river training works and their impact on the physical environment

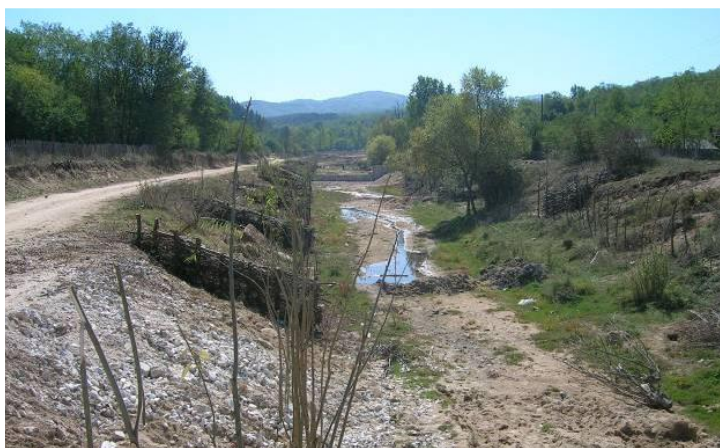
Fig. 3 Willow wattles

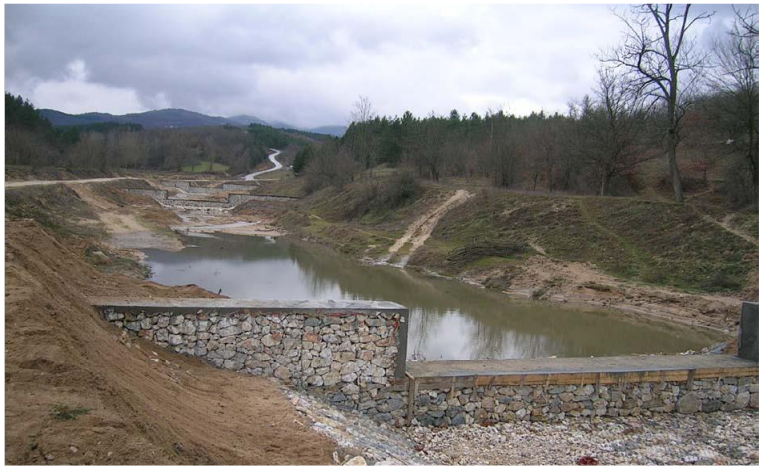
Fig. 4 Cascades
