CONDITION ASSESSMENT AND STRUCTURAL REHABILITATION OF THE ST. NICHOLAS CHURCH IN CRNA TRAVA

Abstract. *The paper analyzes the structural condition of the church dedicated to Saint Nicholas, which is located in the town of Crna Trava, in the south of Serbia. An architectural analysis of the observed structure is provided, as well as an overview of previous works on it, both research and rehabilitation and conservation. A detailed analysis of the structural system of the church is presented. The analysis and classification of the observed damages was performed, the works on the rehabilitation of the building were presented, and a proposal of further remedial measures was given with the aim of preventing further deterioration of the building.*

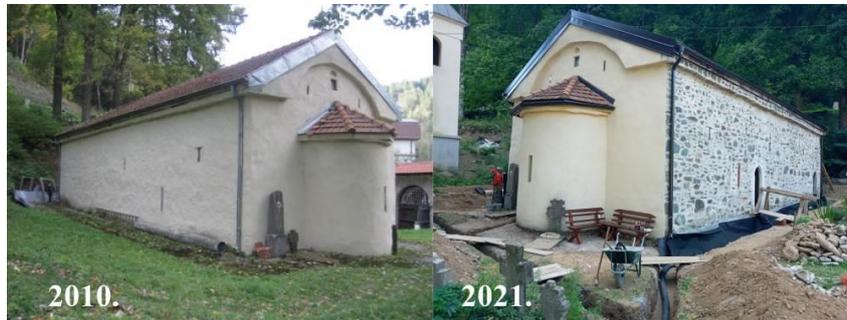
Fig. 1 The St. Nicholas church in Crna Trava (photo: P. Petronijević)

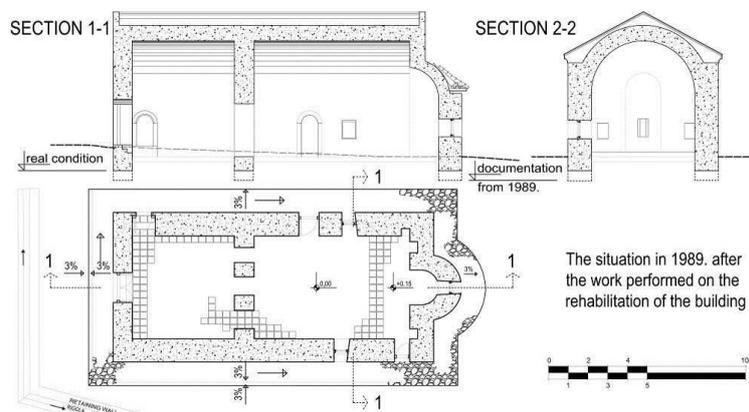
Fig. 2 Plan at the floor level, b) cross-section of a middle bay, condition from 1989, according to the documentation of ZZSK Niš

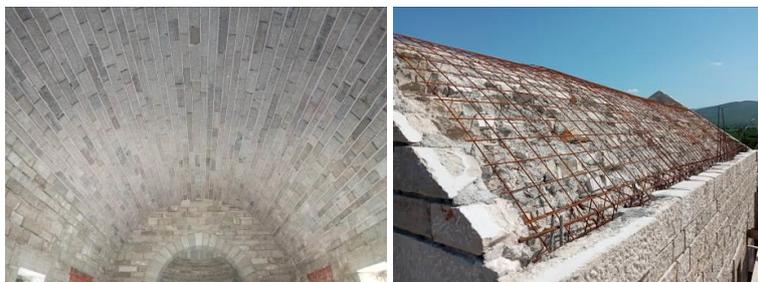
Fig. 5 Reinforcement of the masonry vault with RC shell layer (photo: P. Petronijević)

Longitudinal cracks occur mainly as a result of differential settlement or spacing out of supports. They form on the tensioned side of the plastic joint. They become dangerous only if there are significant horizontal movements of the retaining walls. Cracks at the junction of the vault with the support indicate the process of separation of the vaulted structure and the absence of the transfer of the entire pressure force to the wall. Transverse cracks usually occur at the junction with the transverse walls or at the end of the vault. They are the consequence of inadequately constructed vault-transverse wall connections and the absence of longitudinal constraint of the vault. In modern churches with this type of structure, the crowns of the walls must be strengthened with a horizontal reinforced (RC) concrete ring (Fig. 5).

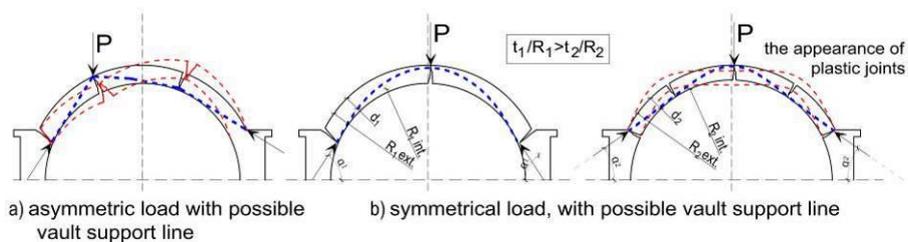
The distribution of cross-sectional forces of arched structures depends on the geometry of the support line, the conditions of support and the load constellation. Asymmetric and concentrated loads are undesirable. Vaulted structures withstand pressure stresses well, which cause oblique reactions of supports. In order to ensure the desired behavior of the vault, the compression force must be as close as possible to the center of gravity of the cross section. The bending moment caused by the eccentricity of the normal force is considered a parasitic influence in arched structures [10]. The ideal shape of the support line is given by the inverted catenary equation [7]. Tension must be prevented, the resulting force must remain in the middle third of the height. The failure of the arches is caused by the occurrence of several plastic joints, which causes the system to become a mechanism.

Fig. 6 Potential fracture mechanisms of barrel vault and arched structures [3]

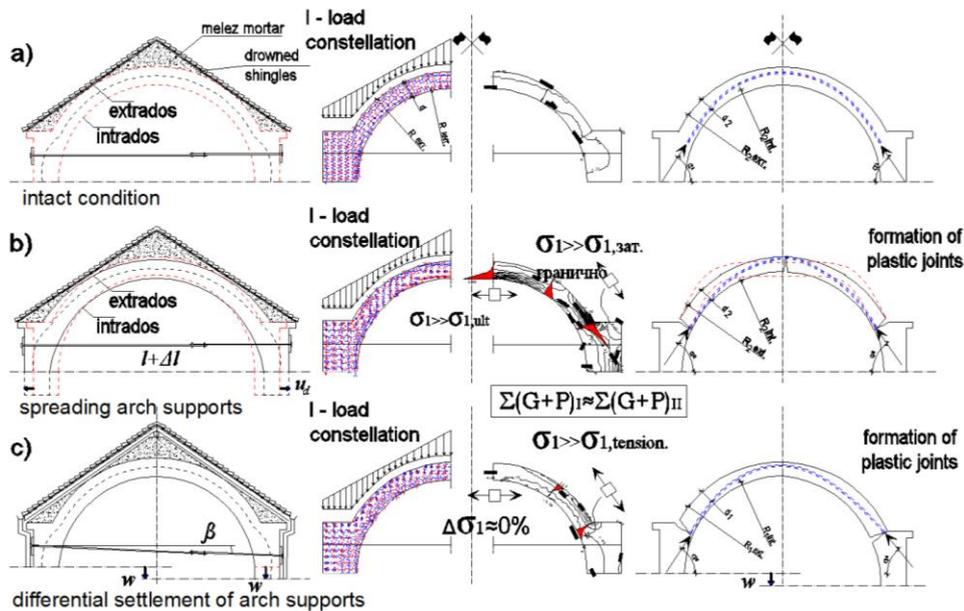
the longitudinal walls. Anchoring was realized with two steel members (see Fig. 7-b) in inadequate places, one brace even passing through the window. Anchoring did not include base plates so there is no possibility of subsequent force correction by increasing the tension. Arched structures are extremely sensitive to the spacing out of the supports. Braces failure and the walls spacing out at the height of the cornice by only 0.1% of the vault the span, increases the tangential tensile stress in the apex and the arch support several tens of times. This exceeds the tensile strength of the mortar multiple times, cracks and fissures occur and the supporting line of the vault is deformed depending on the number of newly formed plastic joints (see Fig. 8-a).

Fig. 8 The influence of wall spacing and different settlement of supports on the change of stress state and the mechanism of vault fracture [3]

The braces failure caused a widespread network of cracks in the vault, which creates a potential danger of their partial collapse. Vertical differential settlement of retaining walls has a significantly smaller impact on the change of stress state in the vault. The observed network of cracks does not indicate this phenomenon. The asymmetrical arrangement of cracks and significant areas of flaked mortar on the intrados of the nave vault occurred as a consequence of the roof leaking over a period of time.

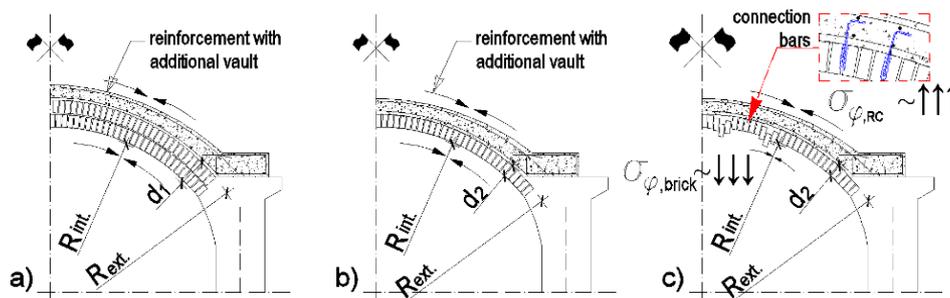
The method of strengthening the vault by increasing the thickness using the concrete saddle, despite its high efficiency, is used cautiously due to incompatibility of mechanical characteristics of concrete and that of the stone or brick vault, asymmetry of cross section and relatively destructiveness of the method [11]. The modulus of elasticity of masonry stone varies a lot and depends on the quality of the stone and the applied mortar, the type of bond and layering of the wall, the degree of stone dressing, etc. The efficiency of the solution largely depends on the degree of bond, so it is necessary to prepare the contact surface and apply anchors that resist the shear between the brick and the RC vault (see Fig. 14). Intrados shotcreting gives partial results in strengthening the vaults due to the small thickness of the additional layer. The method was popular in the 70s and 80s, but in this case it is not applicable so that the frescoes would be preserved.

Fig. 14 Reinforcement with additional vault

The next step of the renovation includes the comprehensive repair of the vaults and the structural grouting of the stone walls. The way in which arched structures behave under static load is conditioned by several types of reinforcement. By changing the geometric shape (thickening of the arch), which affects the shape of the support line of the segments between the plastic joints. The goal is for the geometric shape to make the structure be predominantly stressed by compression, while the radial deformation and tension are limited. By increasing the thickness of the vault, the integrity is restored by removing the two plastic joints. The support line in the case of an arch with developed plastic joints touches the intrados and / or extrados, while with reinforcement it moves back within the geometry of the arch. If the vault shows visible deformations and the beginning of the development of the fracture mechanism, as in the case of the church of St. Nicholas, strengthening and rehabilitation require other types of intervention as well.

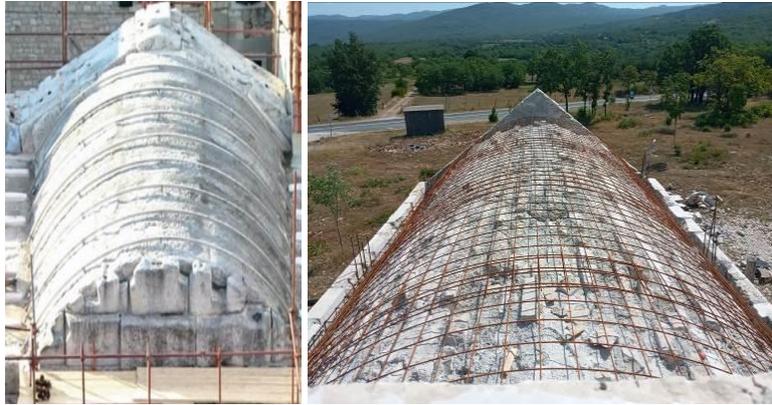
Fig. 15 a) Reinforcement of the vault extrados with steel arches, b) masonry vault reinforcement with additional RC vault (photo: P.P.)

Preservation of frescoes also prevents the application of composite polymers (fiber-reinforced polymer - FRP) on the intrados of vaults. In recent years, the application of FRP has been very common in the rehabilitation and strengthening of masonry and arch structures [8]. FRP reinforcement is very effective because it increases the tensile strength at the places of plastic joints. The method of reinforcement with steel arches is suitable for arches made of large stone blocks. An example of the successful strengthening of the vault with a series of steel arches is the construction of the Temple of Jupiter in Split. The absence of a massive cornice at the level of the arch support limits the application of this method in the case of St. Nicholas church. For that reason, the solution of strengthening the extrados of the vault with an additional layer of reinforced concrete with the addition of a more massive concrete ring beam is more favorable. This efficient solution has been applied many times in practice and is a common procedure for making vaults during the construction of new buildings (see Fig. 15). In this way, the structural response of the vault (load-strain) is significantly improved. Since it is not possible to influence the geometry of the vault during repairs, the stress state can be improved by changing the function of the added vault cross-section. Subsequent arch constraining is difficult to perform, so the support connection is considered hinged or elastically constrained. For most remediation procedures, a constant cross-section of the vault reinforcement is advantageous or it changes so that a larger mass is concentrated along the supports (the thicker the layer of concrete along the supporting walls) At the locations of cracks on the intrados, it is possible to use Polymer-reinforced fibers as these materials give higher tensile strength at the expense of a slight increase in weight [12]. For this purpose, Steel Reinforced Grout can

also be used, which is also an effective solution for strengthening vaults in order to increase their load-bearing capacity and seismic resistance [13-15].
