## **“KARAĐORĐEV DOM” IN RAČA: TAKING THE FIRST STEPS OF CULTURAL PROPERTY REHABILITATION PROCESS**

**Elena Vasić Petrović**

DEarhitektura Niš, Serbia

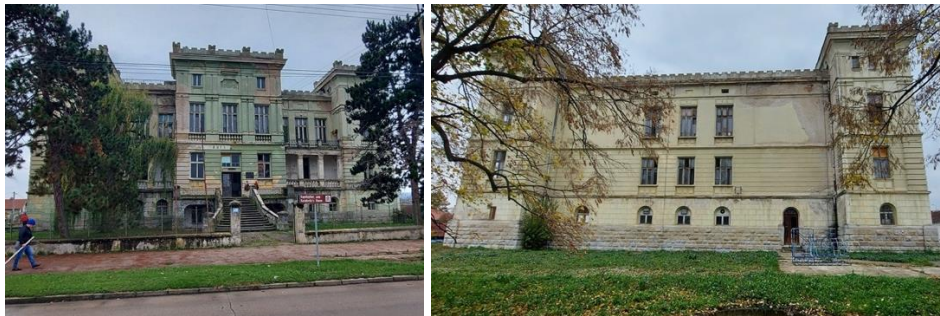
The building is rectangular with the main entrance and monumental staircase, on the northwest façade (see Fig.3). The remaining façades also have entrances, so there is a total of four in the entire building and they are all at ground level (originally raised by 3 steps), except the main one, which is located on the balcony, which is a semi-level between the basement and ground floor.

**Fig. 3** "Karadorđev dom", a view from Karadorđeva street (left), a view from the backyard (right), author: E.V.Petrović (November 2020)
