BELT CONVEYOR DRIVE GEARBOX PROBLEM CAUSED BY UNPAIRED GEARS- A CASE STUDY

Abstract. *Belt conveyors for all kinds of materials are very important piece of equipment in mining and excavation industries. This paper presents a case study analysis of vibration on a belt conveyor driving unit. The analyzed belt conveyor is operating in copper production plant and it is conveying copper ore from mining site to process plant. In order to detect the possible defects in belt conveyor drive units, vibration measurements are conducted in all four drive units. Measurement points are set on bearing housings of electric motor and gearbox as defined by ISO 10816-1.*

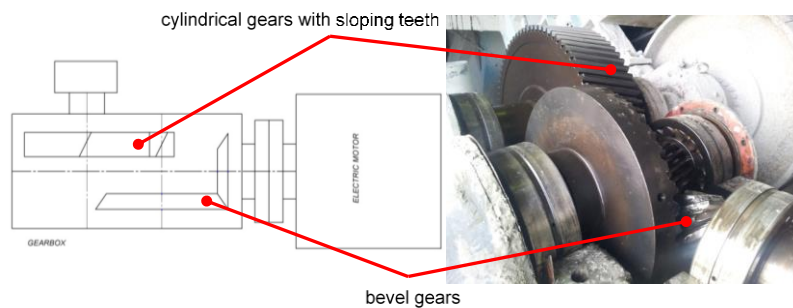
Fig. 2 Schematic display of driving unit and picture of two stage gearbox

Gearbox is a two-stage gearbox with transmission ratio of $i=22,4$. The first stage are the pair of bevel gears; bevel gear pinion $z=10$; driven bevel gear $z=41$. The second stage are the pair of cylindrical gears with sloping teeth; pinion $z=15$; driven gear $z=82$ (Fig. 2).
