Series: Architecture and Civil Engineering Vol. 14, No 3, 2016, pp. 367-375

THE SELAMLUK IN VRANJE (PART I): ARCHITECTONIC FORM DEVELOPMENT BASED ON HISTORICAL SOURCES

Abstract. Pašini konaci (Pasha's residence), Selamluk and Haremluk in Vranje, are typical representatives of Balkan Oriental architecture of 18th century. In spite of the buildings becoming very decrepit and prone to dilapidation due to their structural characteristics, in terms of their function and construction technique, they represent an evidence of the living standard of a social class and the social relationships of the historical age they belong to.

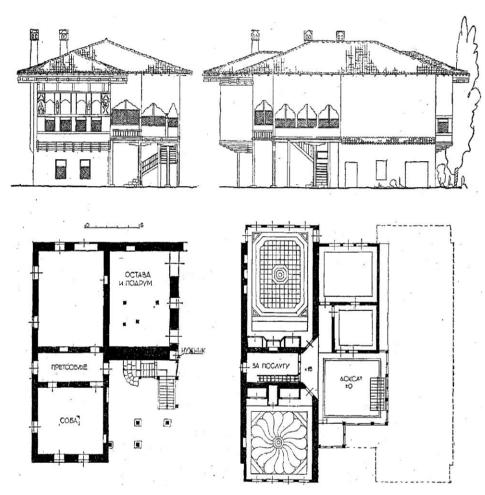
Fig. 1 Residence of the Dzinoli family in Gnjilane, asymmetrical, humbler than their home in Vranje, (B. Kojić, 1949, 85)
