ACCIDENT PREVENTION IN SEVESO FACILITIES: EXAMPLE OF THE COPPER FLOTATION PLANT IN BOR

**Emina Mihajlović, Lidija Milošević, Jasmina Radosavljević,
Ljiljana Živković, Miomir Raos**

Faculty of Occupational Safety in Niš, University of Niš

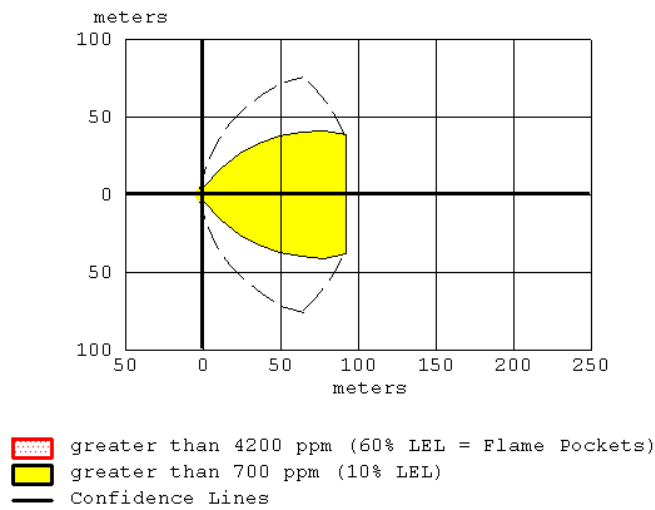
Fig. 5 Zone vulnerable to fire

To model the effects of fire, we used ALOHA and CAMEO software suites. We made the calculation for the worst possible scenario – spillage and fire in the reagent repository. The model is based on the amount of 20 [t] of reagent D-250. This reagent was selected because its physicochemical parameters are well known, whereas the majority of KEX reagent parameters required for the calculation were not available. We did the calculation based on the atmospheric temperature of 15 [°C].

Figure 5 shows the zone in which a fire can occur if there is an ignition source present together with reagent D-250 vapours. The hazardous concentration level at which a fire can occur if an ignition source is present extends to 90 [m] of the spillage point.

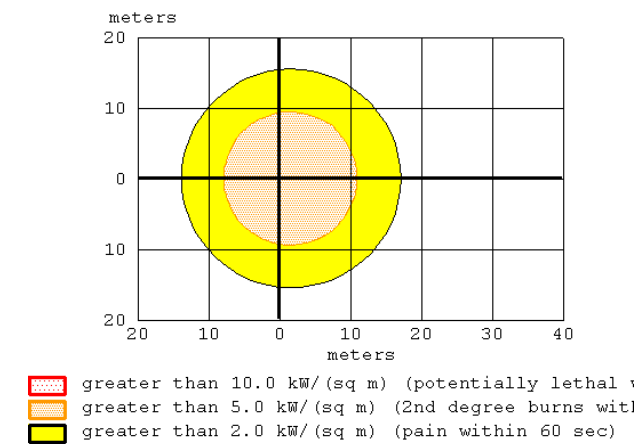
Fig. 6 Vulnerable zone in the event of fire

There are three possible hazard zones in the event of fire (Figure 6):

Hazard zones are found only inside the repository.

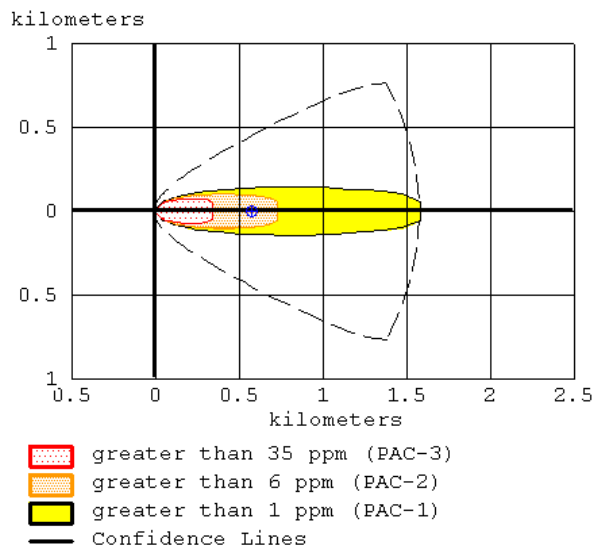
Fig. 7 Vulnerable zone due to reagent spillage without a fire

Figure 7 shows the vulnerable zone for the worst case scenario of spillage of the entire amount of reagent in the repository and vapour dispersion without a fire. The dashed line represents windward vapour propagation.

Figure 7 indicates the following:
